INSPECTION REPORT  
101 Main Lane  
Richmond Hill GA 31420

INSPECTED BY  
Keith Ware  
Pride Home  
Inspections, LLC

INSPECTION DATE  
📅 11/7/2025  
🕒 12:00 PM

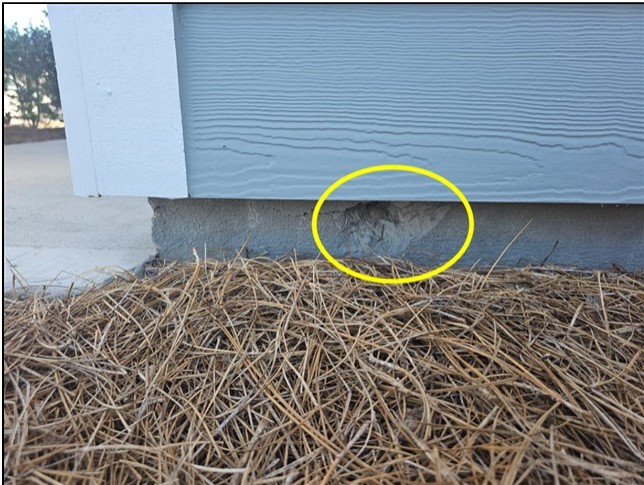
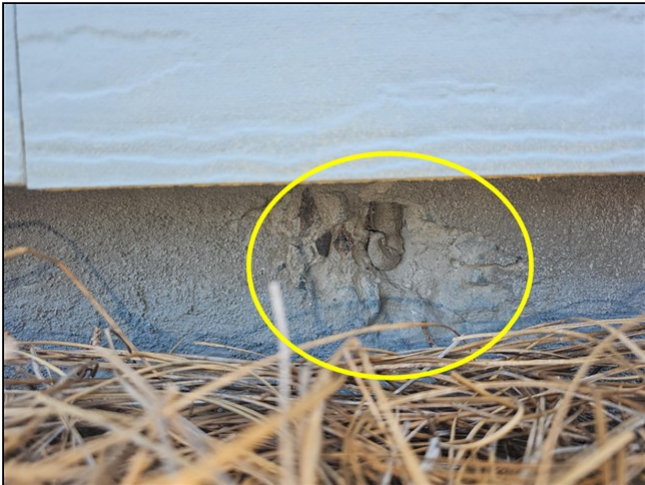
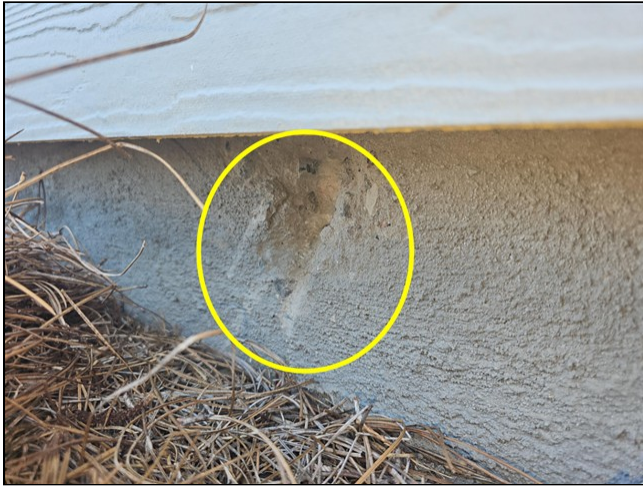
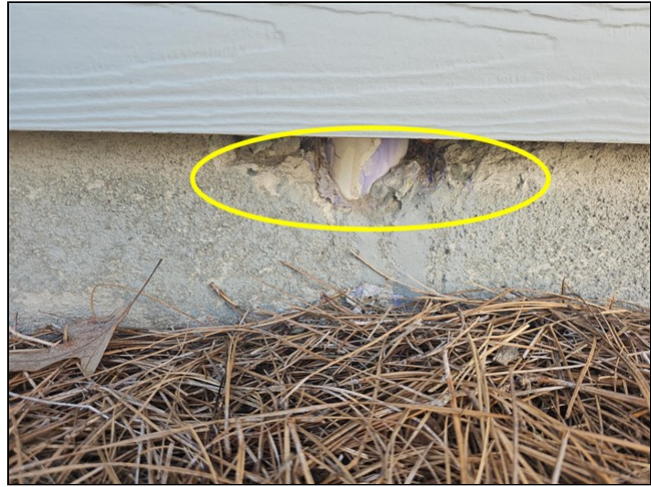
Comment: Superficial chipping, which does not have a negative impact on structural integrity, is often the result of minor impacts during installation and can be managed with basic cosmetic repairs.

chipped concrete at multiple locations around edge of foundation

Recommendation: Repair by a concrete contractor.

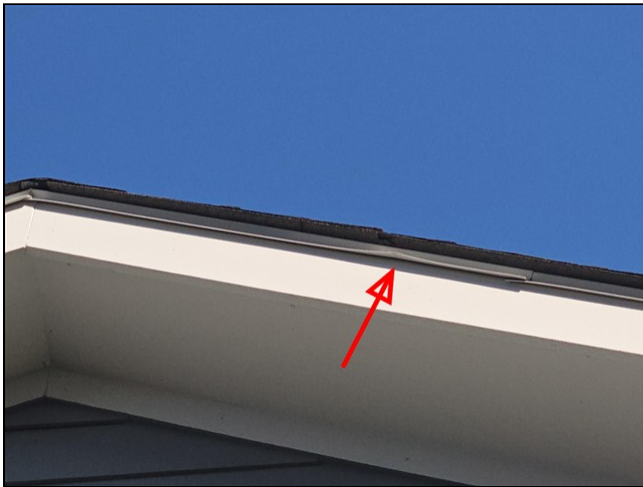
Comment: The drip edge flashing is installed to protect your home by directing water away from the fascia and roof decking, preventing moisture damage and rot. This L-shaped metal piece sits at the roof's edge, either guiding water into gutters or off the roof's edge. By preventing water from seeping under shingles and behind the fascia, it prolongs the life of your roof and structural components.

deflected drip-edge flashing at right gable rake

Recommendation: Flashing repair by a licensed roofer.

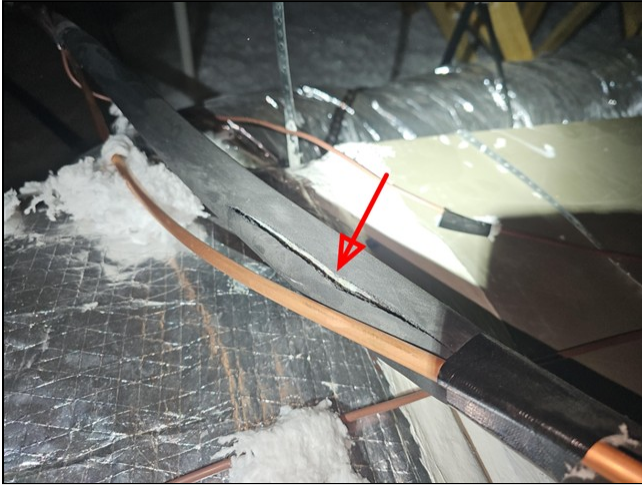
Comment: Condensation will form on the outer surface of the copper refrigerant line when the unit is in operation. Gaps in the insulation will allow condensation to leak which creates a moisture-rich attic environment that may facilitate fungal growth as well as causing moisture damage to the attic flooring and, over time, the interior ceilings below.

gaps in refrigerant line insulation in attic

Recommendation: Repair by a licensed HVAC technician.

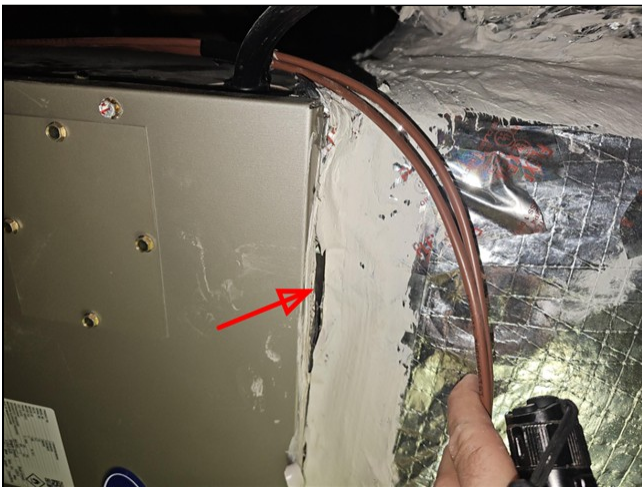
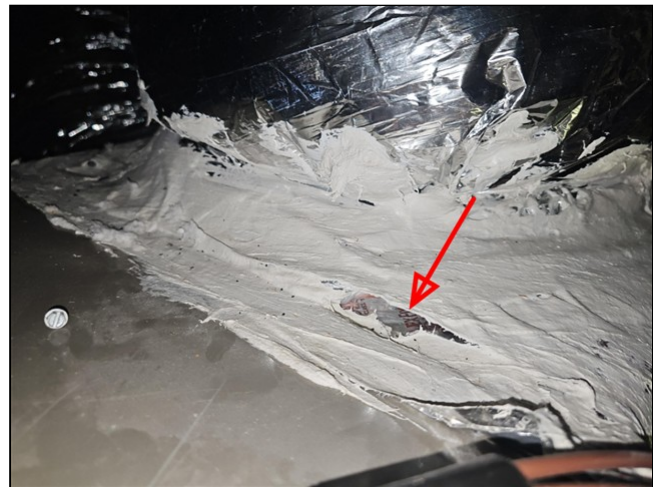
**3.4 Observation:** At the interior HVAC unit in the attic, air leaked from the air supply plenum at multiple locations due to gaps in the mastic sealant where the ducts were connected to the plenum.

Comment: Conditioned air escaping into the attic can create a moisture-rich environment that facilitates mold/mildew growth.

gap in mastic at interior unit allowed air leakage

Recommendation: A licensed HVAC technician repair the gaps in the mastic sealant at the interior unit to stop air leakage.

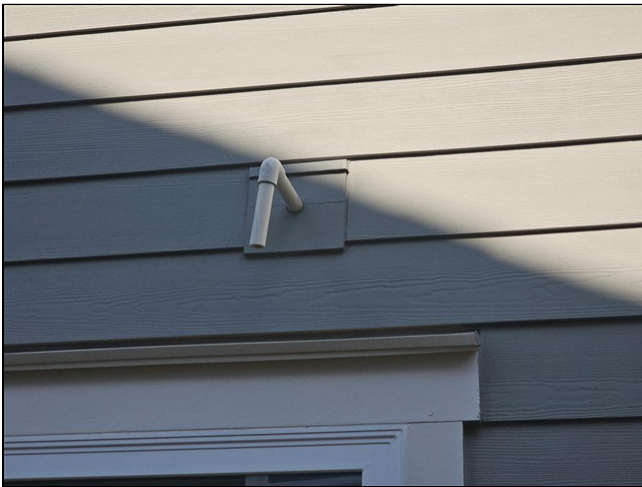
**3.5 Observation:** An HVAC condensation drain line was installed over a window on the right exterior wall. Additionally, there was a horizontal crack in the mounting block that may allow leakage.

**Comment:** Condensation discharged from this drain line in the future is likely to stain the window below over time and reduce visibility. Additionally, the horizontal crack in the mounting block may allow leakage.

condensation drain line positioned above window on right exterior wall

1. A qualified contractor relocate the condensation drain line so that it does not discharge onto a window.
2. A qualified contractor replace the cracked mounting block.

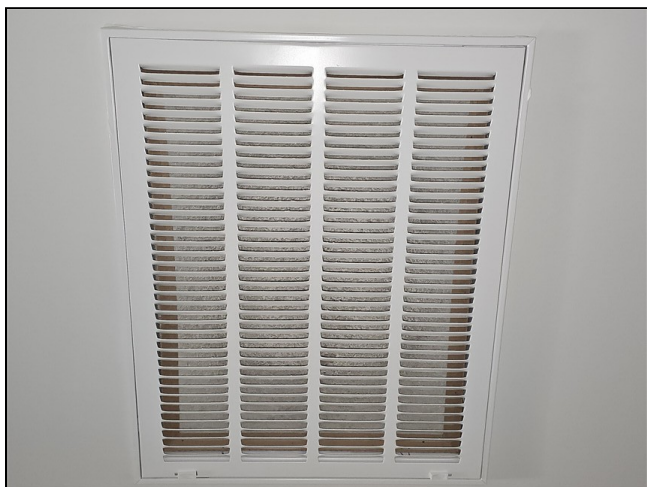
**3.7 Observation:** The air return filters were clogged/dirty.

A clogged air return filter has several negative impacts on your HVAC system, including reduced airflow, increased energy consumption, and potential damage to system components if there is persistent negligence.

filters were clogged

**Recommendation:** Replace the filters at the earliest opportunity and do so again every 30 days thereafter.

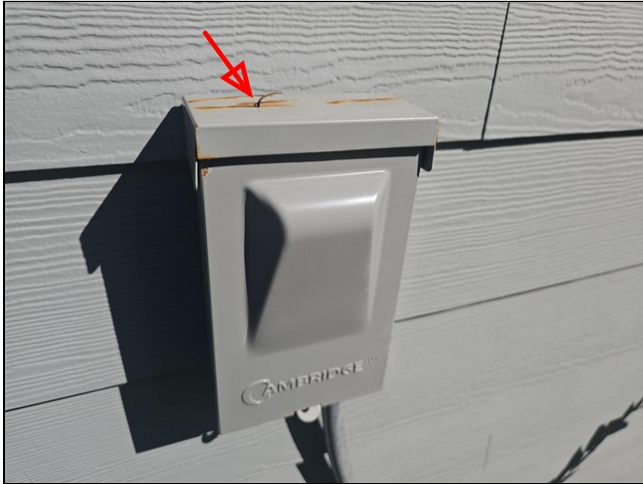
**3.8 Observation:** A corroded maintenance disconnect box at the exterior unit.

**Comment:** Several small cuts were made in the top of the box which damaged the protective coating and allowed it to corrode. The corrosion will likely worsen over time.

maintenance disconnect behind exterior unit:  
corrosion caused by damage to protective  
finish

**Recommendation:** A licensed electrician replace the damaged maintenance disconnect box.

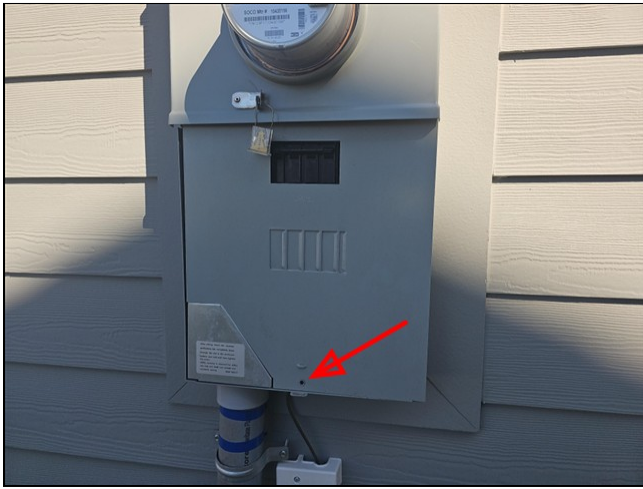
**4.1 Observation:** A fastener was not installed; the service panel dead-front was not secured.

service panel dead-front was not secured:  
missing fastener

**Recommendation:** A qualified contractor install a manufacturer-approved fastener.

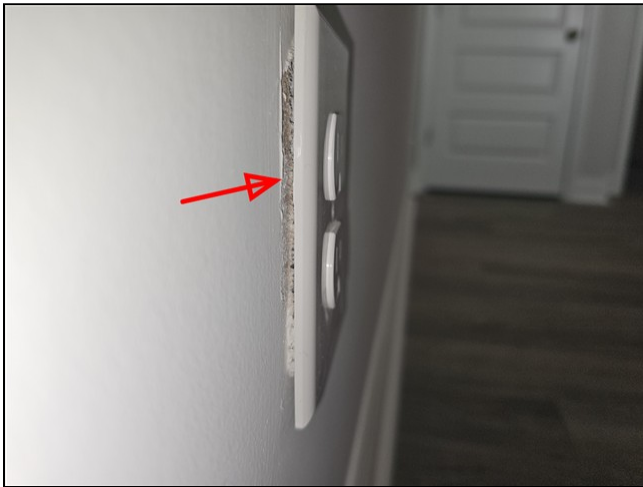
**4.7 (2) Observation:** There was a gap between the wall and coverplate at multiple interior receptacles and switches. Cover plates should sit flush against the finished surface of the wall.

gap between wall and cover plate at multiple interior receptacles and switches

**Recommendation:** A licensed electrician evaluate each receptacle and switch in the home and repair

any where gaps are present between the wall and coverplate.

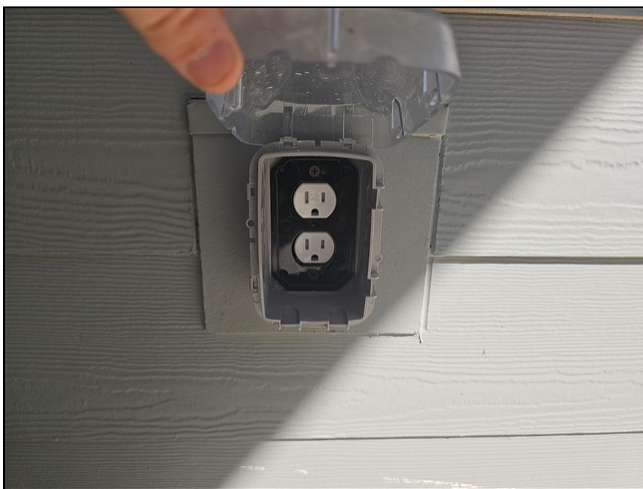
**4.8 Observation:** Loose electrical receptacle at the patio.

**Comment:** Over a period of time and after continued use, wires can loosen and even become disconnected.

loose receptacle at patio

**Recommendation:** Repair by a licensed electrician.

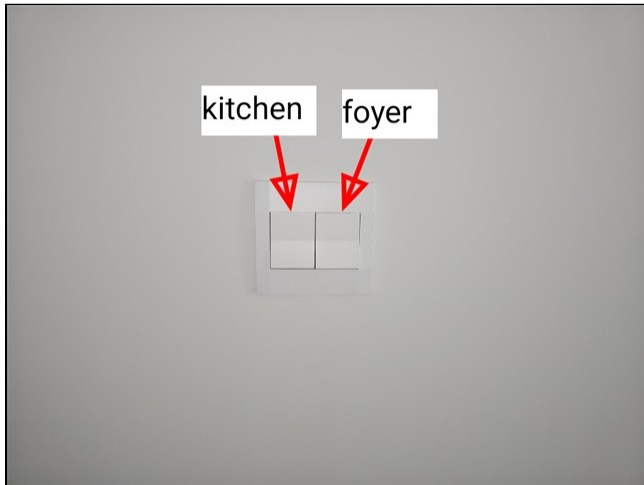
**4.10** Observation: The light switches at the referenced location were not installed in an intuitive manner. The switches were on the side opposite of the room of whose lights they controlled.

kitchen light switch: oriented backwards

Recommendation: Repair by an electrician.

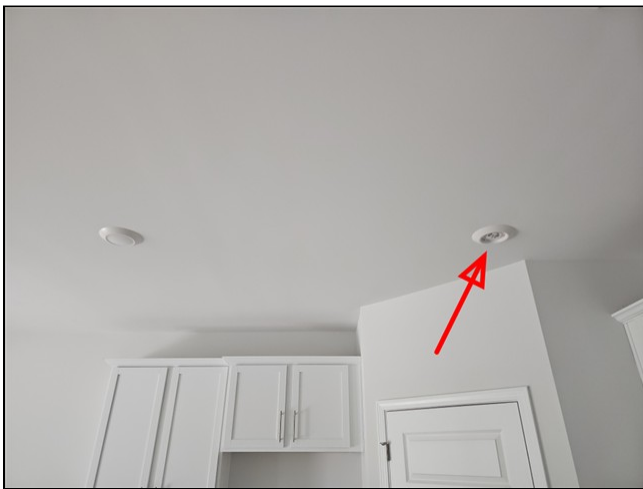
**4.11** Observation: The cover was missing at one recessed light fixture in the kitchen.

kitchen: recessed light fixture cover was missing

Recommendation: Repair by a qualified professional.

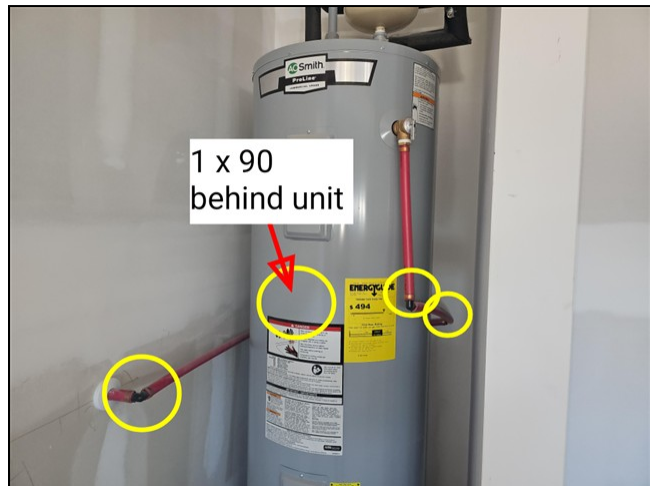
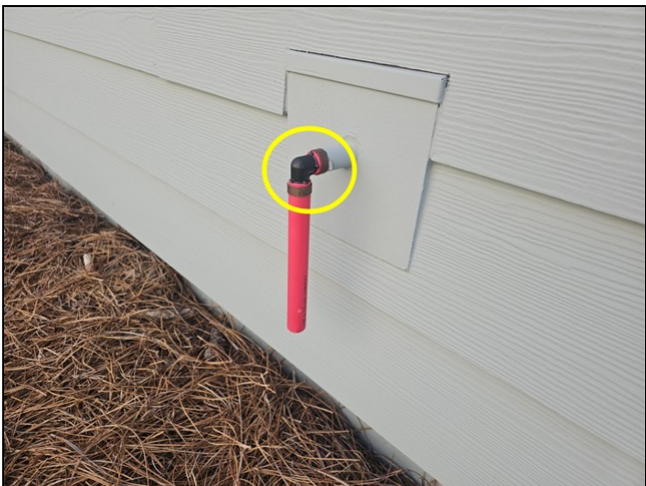
Comment: There is a limit to the number of elbows in a TPR (Temperature and Pressure Relief) drain line to prevent restricting the valve's ability to quickly and safely release hot water in an emergency. Too many turns or excessive length create back pressure and head, which can impede flow and decrease the discharge capacity, potentially causing the pipe to fail or not function correctly.

excessive amount of connections in TPR drain line

Recommendation: Repair by a licensed plumber.

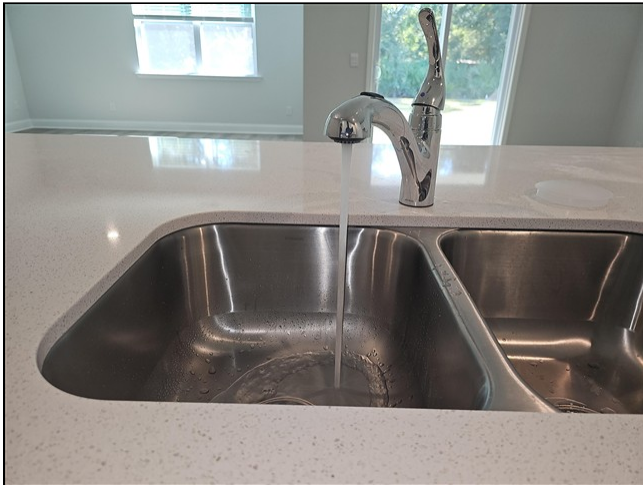
**5.1 (2) Observation:** The water had a mild sulfur smell at most fixtures.

**Comment:** A sulfur smell from a water heater is usually caused by bacteria in the water or a reaction with the anode rod, which can be fixed by flushing the tank and potentially replacing the rod.

water had sulfur odor

1. Flush the tank to kill the bacteria.
2. Replace the anode rod if needed.

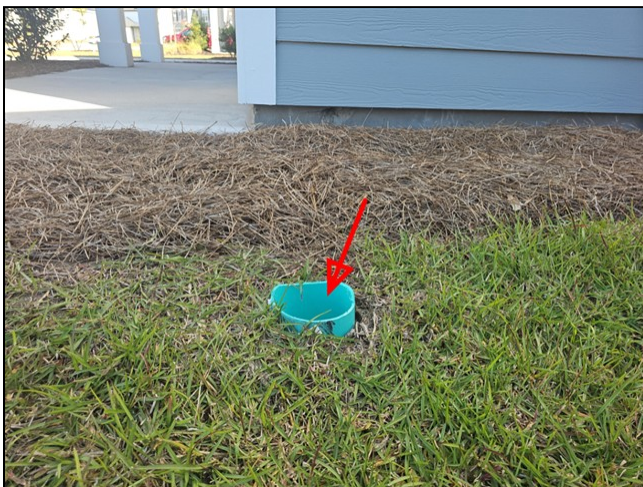
**5.6 (1) Observation:** An unsealed plumbing drain cleanout at the referenced location.

right-front corner: un-capped plumbing drain cleanout

**Recommendation:** Repair by a licensed plumber.

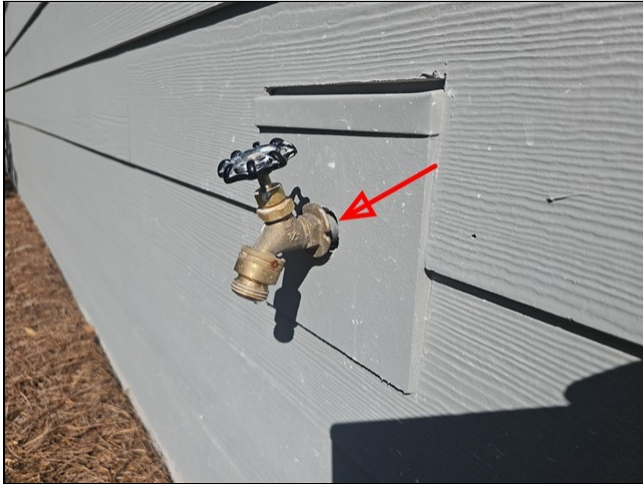
**5.6 (2) Observation:** A hose bib was unsealed at the referenced location.

Comment: Unsealed exterior wall penetrations may allow water to leak behind the siding where moisture damage will occur.

right-rear corner: unsealed hose bib

Recommendation: A qualified professional seal the hose bib at referenced location.

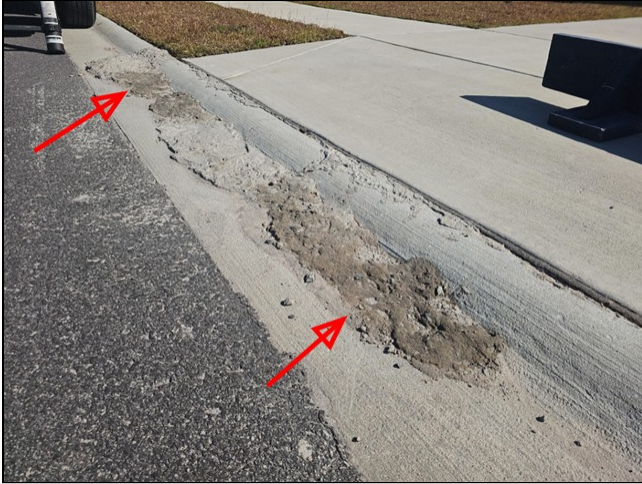
construction debris (hardened concrete) at edge of driveway

**Recommendation:** A concrete contractor remove the hardened concrete and repair the curb if necessary.

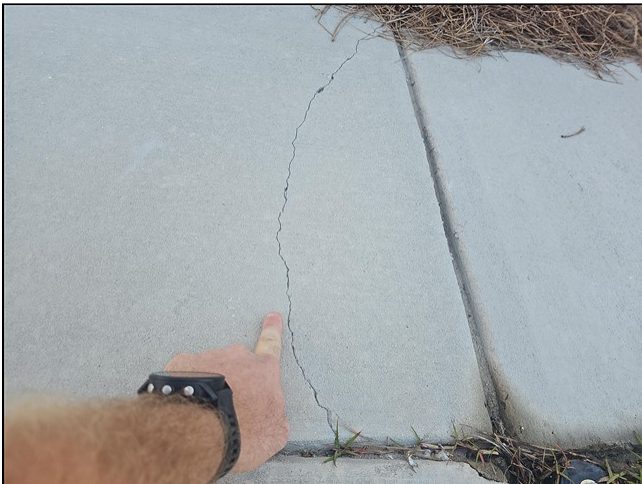
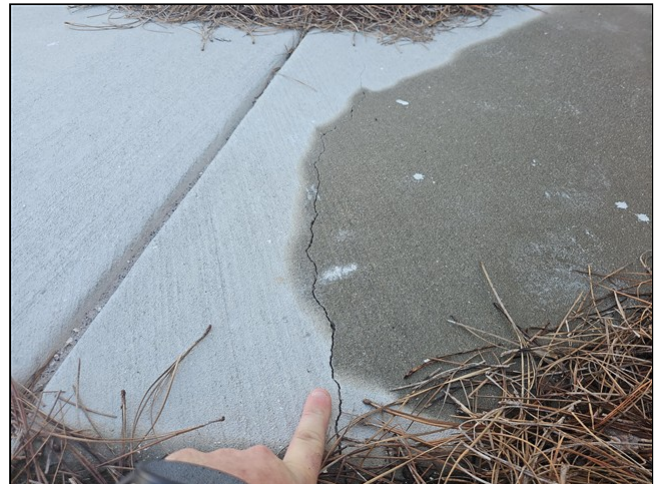
**6.2 Observation:** Two typical cracks traversed the front walkway.

**Comment:** Concrete cracks are fairly common and occur for a variety of reasons during or after installation. The vast majority of cracks are no cause for concern.

hairline cracking in front walkway

hairline crack in front walkway

**Recommendation:** Further evaluation and repair as needed by a concrete contractor.

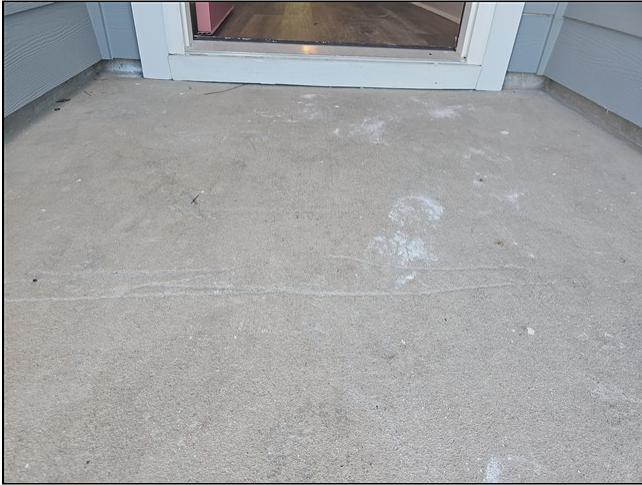
**6.3 Observation:** There were multiple shallow gouges in the concrete front porch.

front porch: gouges in concrete

**Recommendation:** A concrete contractor resurface the front porch to improve appearance.

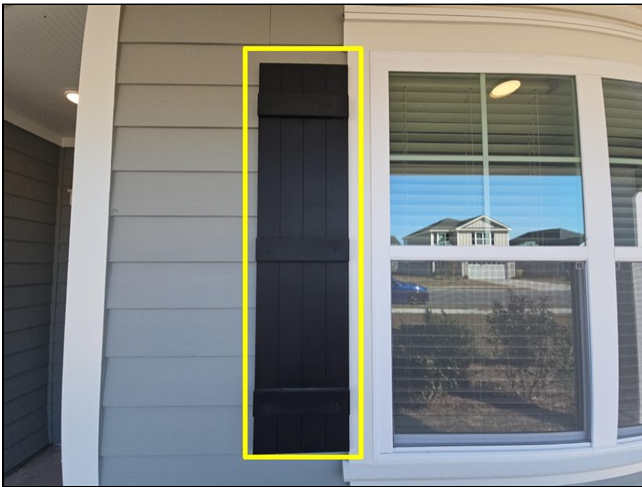
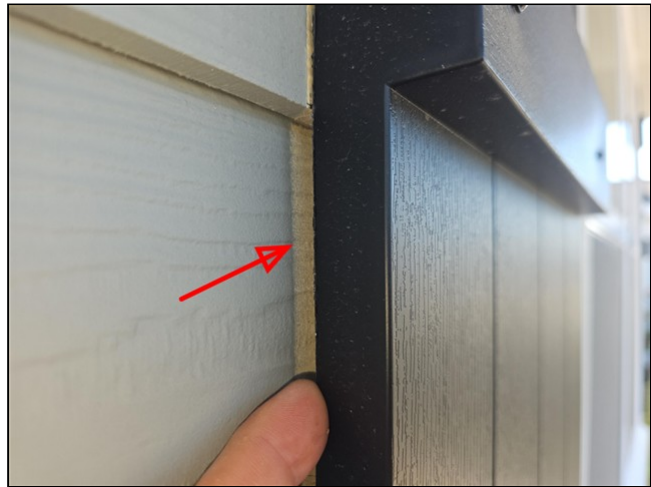
**6.5 (1) Observation:** The exterior walls were unpainted behind the decorative shutters on the front porch.

exterior walls were not painted behind decorative shutters

unpainted wall behind decorative shutters on front porch

**Recommendation:** A professional painter remove the shutters and paint where missing.

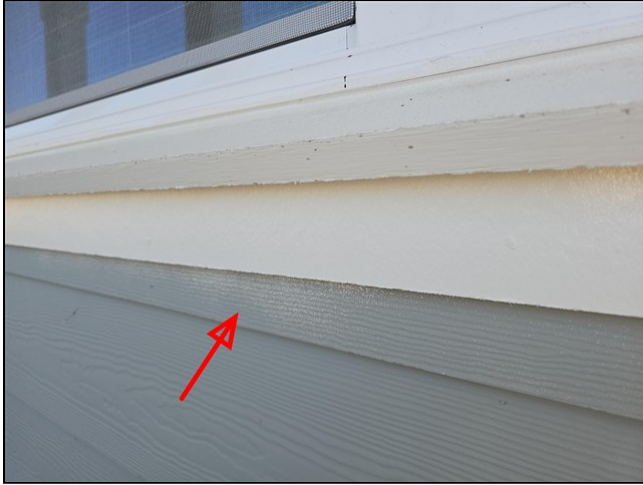
**6.5 (2) Observation:** White paint overspray on the exterior wall beneath the window at the front porch.

paint over-spray on wall at front porch

**Recommendation:** Repair by a professional painter.

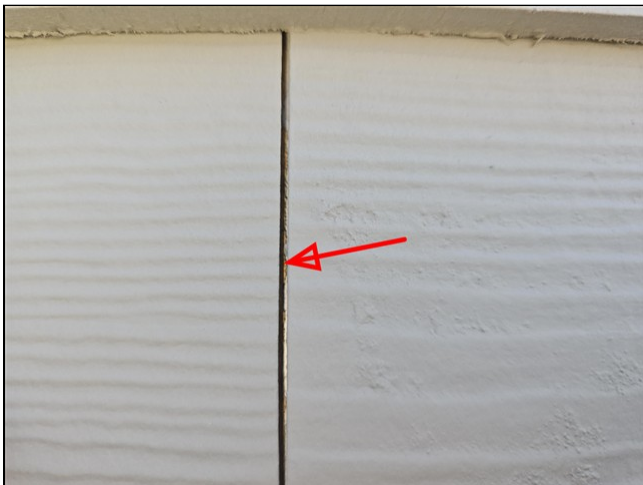
**6.6 (1) Observation:** Flashing was not visible between the butt-joints of the cementitious siding.

**Comment:** Hardie-plank, a leading manufacturer of cementitious siding, recommends installing aluminum flashing behind each butt-joint to prevent moisture intrusion.

manufacturer-recommended flashing was not visible behind siding butt joints

**Recommendation:** Further evaluation by a cementitious siding specialist to (a) confirm/deny presence of flashing behind butt-joints at several locations and (b) repair and install additional flashing as needed.

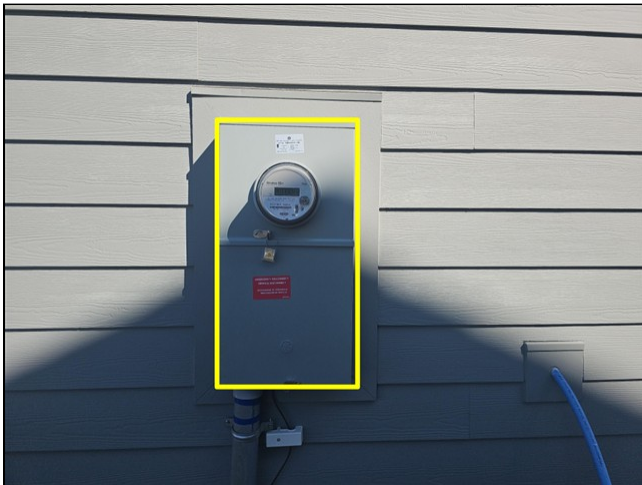
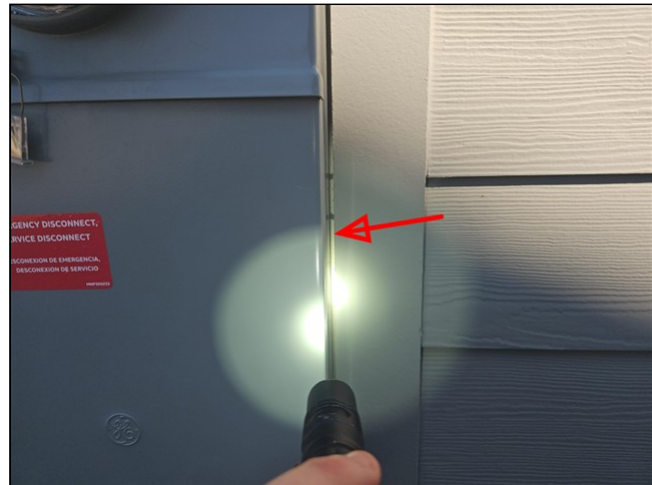
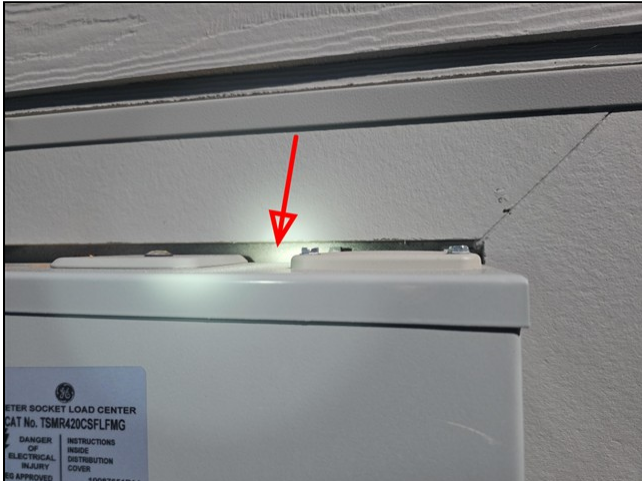
**6.6 (2) Observation:** The electrical service panel appeared to be installed in a manner that may allow moisture intrusion around its edges.

service panel installed directly to wall, recessed within flashed mounting block

weather-resistant barrier visible

poorly sealed around edges of panel

**Recommendation:** Further evaluation by a cementitious siding specialist to (a) confirm/deny presence of flashing around the entire perimeter of the panel that would prevent moisture intrusion and (b) install flashing where missing if necessary.

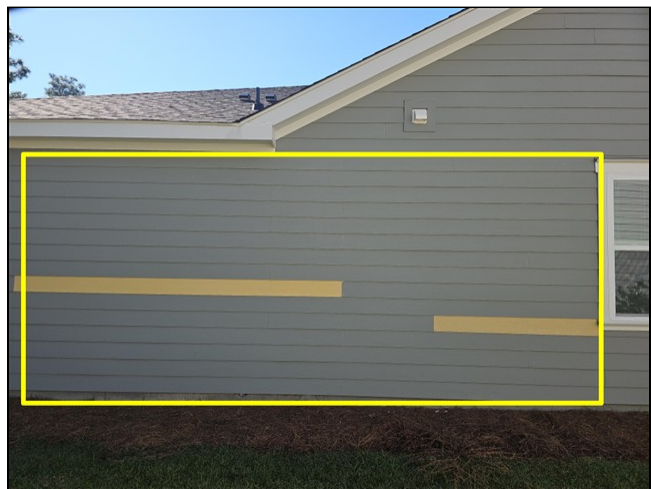
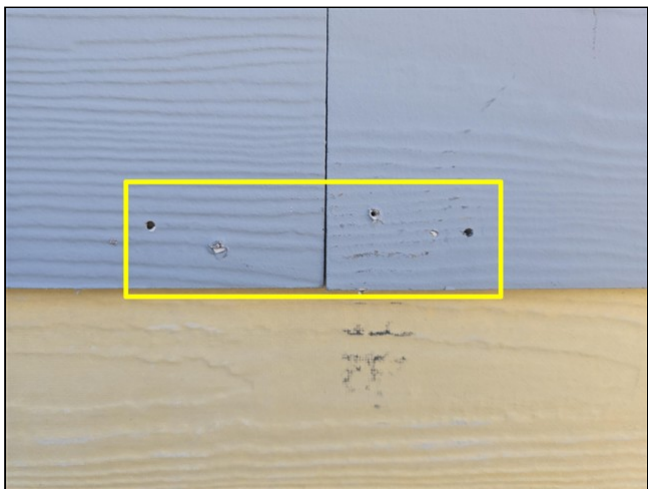
**6.6 (3) Observation:** Poorly installed siding on the left side of the home.

- The siding in this area was face-nailed. Most manufacturer's of cementitious siding recommend blind-nauling as opposed to face-nauling. If face-nailed, the nail heads must be sealed to prevent moisture intrusion, which they were not.

- There were two unpainted planks.

general location of affected siding

siding was face-nailed in several locations in this area

Recommendation: A cementitious siding specialist evaluate the condition of the siding in this area and repair as needed according to manufacturer's installation guidelines.

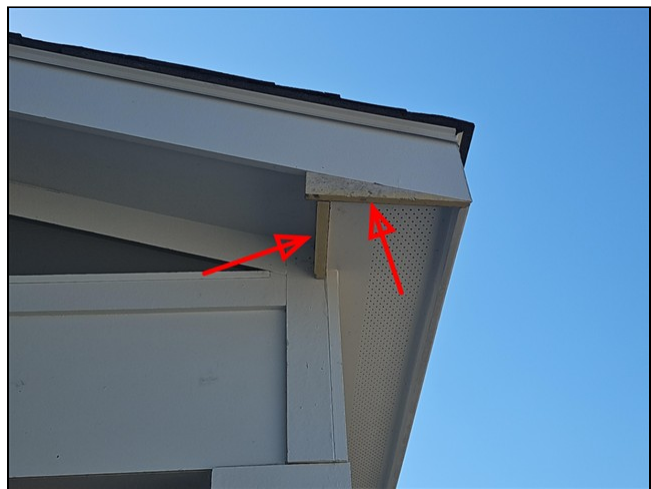
**6.6** (4) Observation: Unpainted trim at the front porch overhang.

unpainted trim at front porch overhang

Recommendation: A professional painter paint the trim to match surrounding trim.

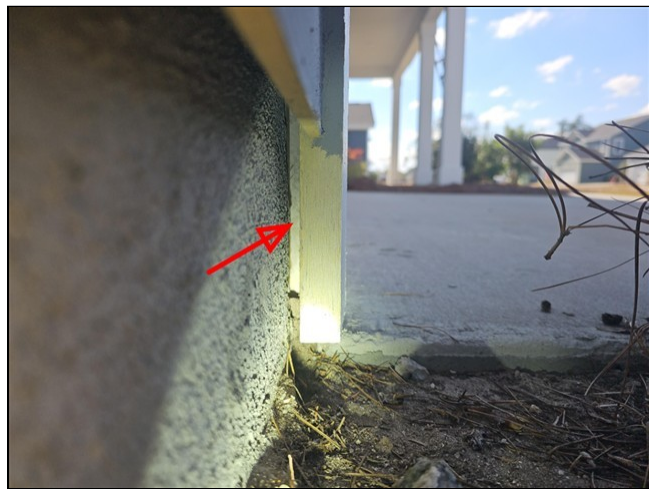
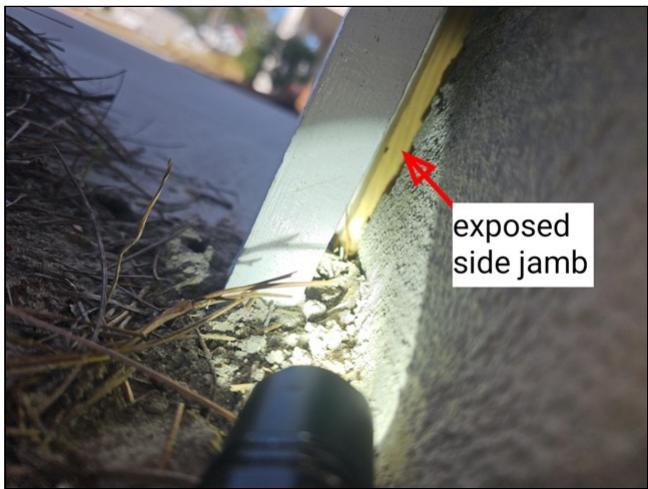
**6.6** (5) Observation: The wood studs were exposed at the lower left and right corners of the garage door, leaving the wood susceptible to future moisture damage.

lower exterior corners at garage door were unsealed

Recommendation: A qualified professional install flashing here to prevent future moisture damage.

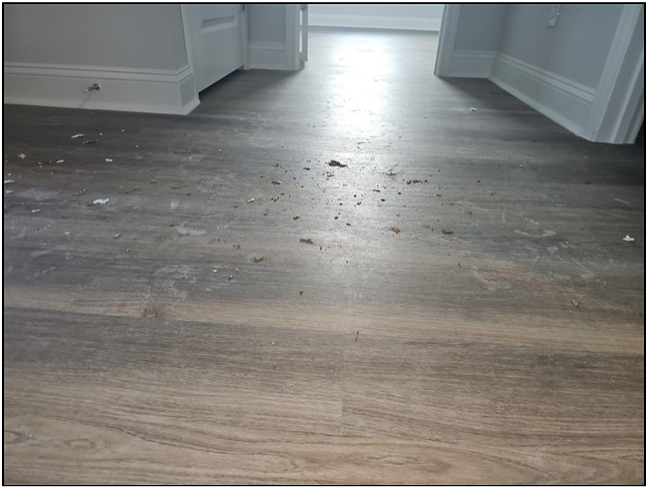
**7.0 Observation:** Construction debris was strewn on interior floors in many locations.

construction debris strewn on interior floors

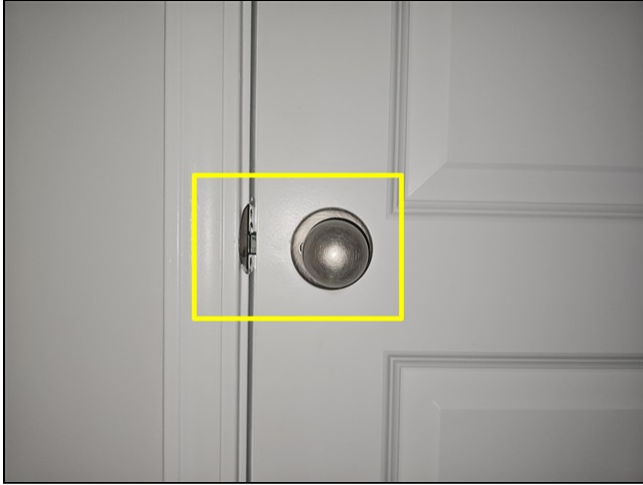
**7.3 Observation:** The hall closet door (near laundry room) did not latch properly when closed due to a misaligned latch & catch plate.

hall closet door did not latch due to misaligned catch plate

**Recommendation:** Repair by a carpenter.

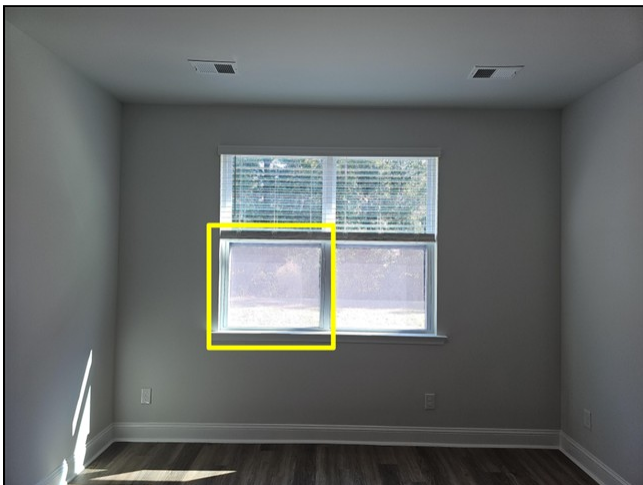
**7.4 Observation:** The referenced window in the primary bedroom was difficult to open and close.

**Comment:** A difficult window is often caused by dirt and debris buildup, leading to increased friction. Other common issues include a misaligned or distorted frame, a tight or broken spring mechanism, or damaged hardware, such as rollers.

primary bedroom: difficult window

**Recommendation:** Repair by a window specialist.

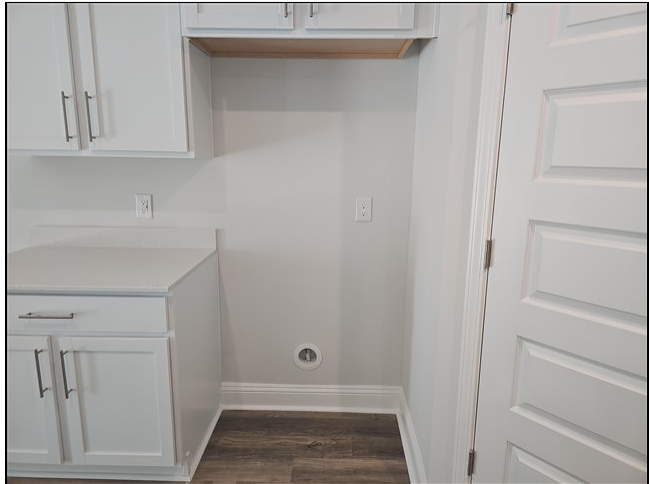
**8.0** Limitation: A refrigerator was not installed; not inspected.

refrigerator not installed

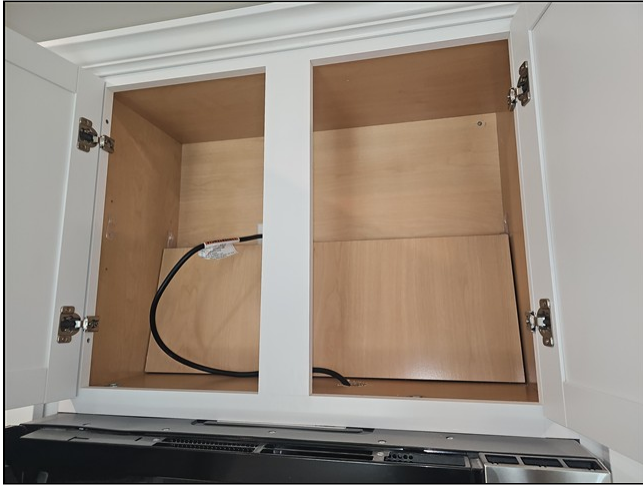
**8.6 Observation:** The shelf in the cabinet above the built-in microwave was not installed.

cabinet shelf above microwave not installed

**Recommendation:** Installation by a qualified professional.

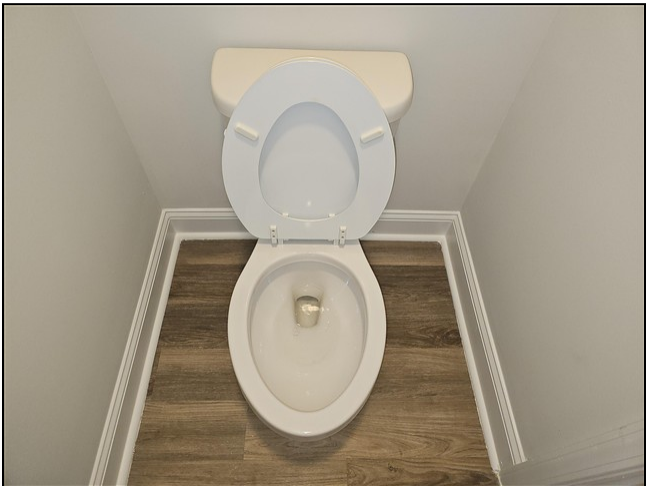
primary bathroom toilet: weak flush

**Recommendation:** Repair by a licensed plumber.

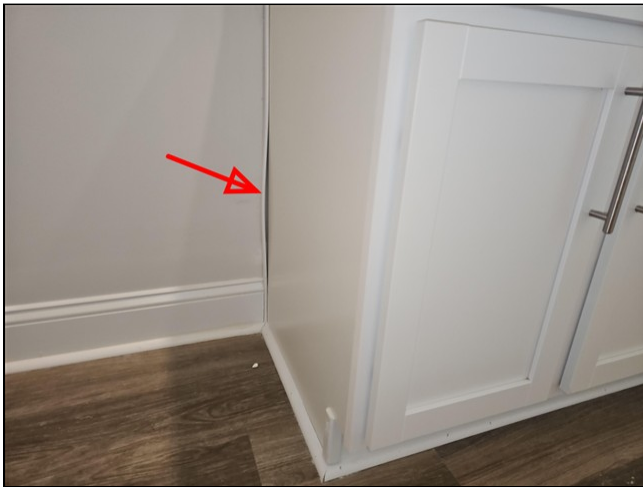
loose cabinet trim in primary bathroom

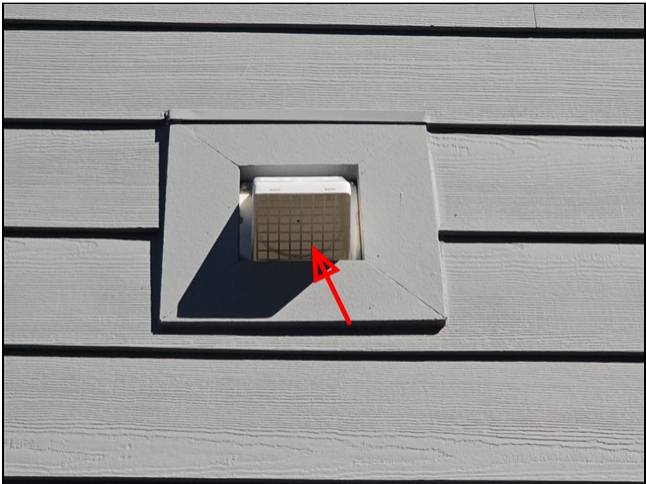
Comment: Over time, lint buildup on the screen will inhibit air flow, increase drying times, and ultimately constitute a fire hazard.

dryer vent screen not removed, may result in lint buildup

Recommendation: Remove the plastic screen to prevent future lint accumulation.

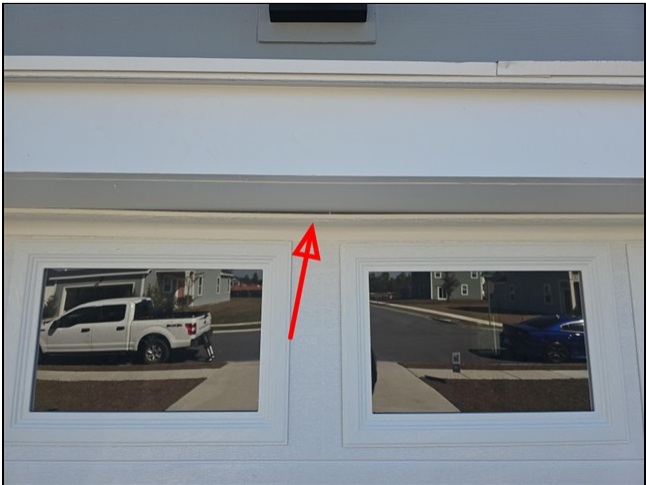
**12.0** (1) Observation: The exterior seal at the garage door sagged at the upper edge.  
Recommendation: Repair by a qualified professional.

loose garage door seal

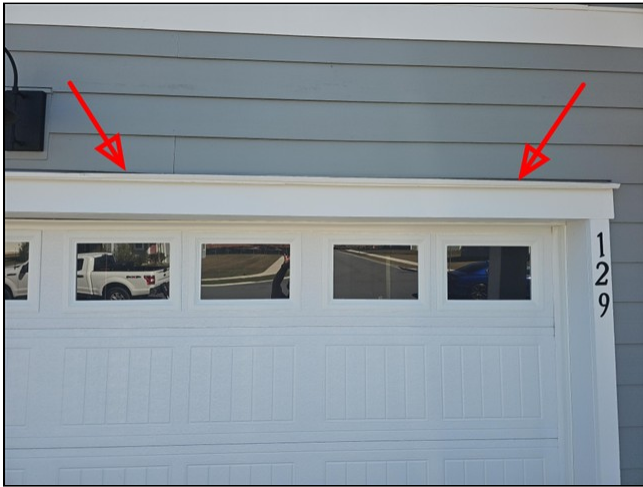
**12.0** (2) Observation: Loose flashing above garage door. Loose flashing may not function as intended

and is more susceptible to wind damage.

Comment: Flashing is installed wherever there is an increased risk of moisture intrusion.

loose flashing above garage door

Recommendation: Repair by a qualified professional.

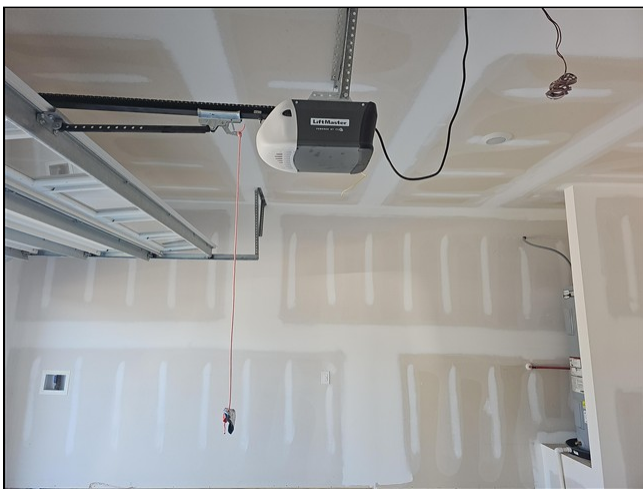
**12.1** Observation: The garage door opener was inoperable. The wall switch did not cause any reaction from the door opener.

garage door opener was inoperable / may require additional programming

Recommendation: Further evaluation and repair as needed by a garage door technician.

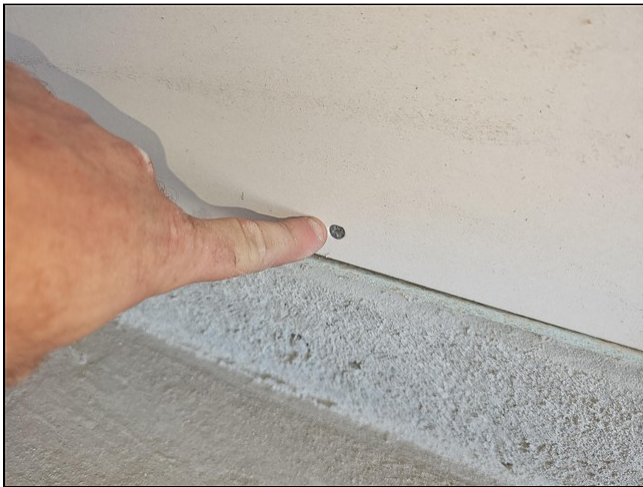
Comment: A firewall between the garage and living area is a safety requirement to prevent fire from spreading from the garage to the home, providing crucial time for occupants to escape. Garages are considered high-risk areas because they store flammable materials like gasoline and paints, and vehicles can leak flammable fluids that may ignite.

unsealed fasteners in garage drywall that reduce firewall effectiveness

Recommendation: A qualified professional seal fastener heads on garage drywall where necessary.
