INSPECTION REPORT  
207 Juniper Court  
Savannah GA 31405

INSPECTED BY  
Keith Ware  
Pride Home  
Inspections, LLC

INSPECTION DATE  
📅 11/10/2025  
🕒 10:00 AM

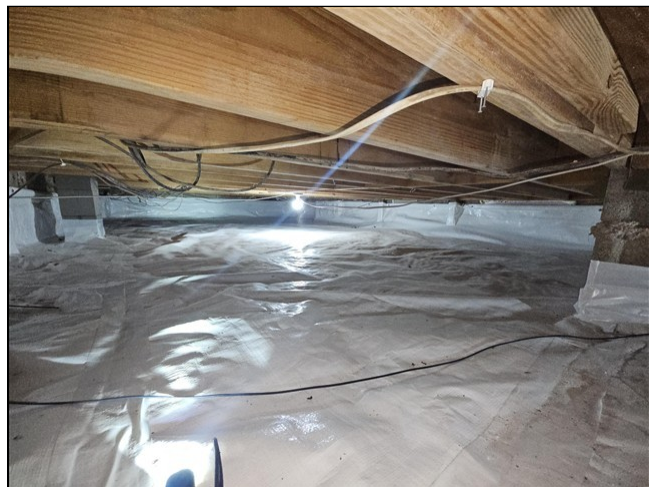
| <p><b>1.0 Observation:</b> Multiple deficiencies were noted within the foundation system that should be further evaluated by a specialist.</p> <p>1. There were no support piers installed in a large area beneath the living and dining rooms. The required layout of support piers is dependant upon load calculations determined by an engineer which far exceed the scope of a home inspection. That said, the typical layout of CMU piers is one every 8 feet.</p> <p>2. Floor-to-wall separation was observed in the bedrooms on the left side of the home. The floor was sagging here and appeared to have settled in certain locations, likely due to a deficiency in the foundation.</p> <p>3. One CMU pier was improperly oriented which may compromise its ability to bear weight. CMU piers should be oriented such that the open cores face upward.</p> <p>4. It was apparent that past repairs were made to the foundation. Recommend that you acquire documentation of the repair from the seller to obtain any transferable warranty that may exist.</p> |

no support piers installed at front-right corner in crawlspace

Recommendation: A foundation specialist should perform a comprehensive evaluation of the home's foundation and repair as needed. The specialist's evaluation should include the entire foundation system and not only the items mentioned above.

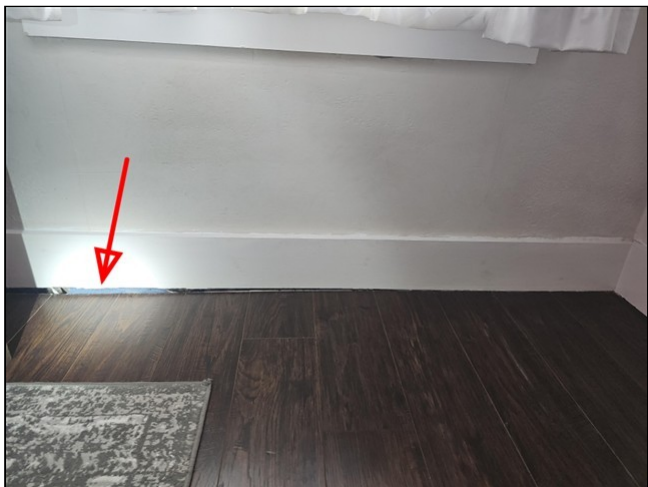
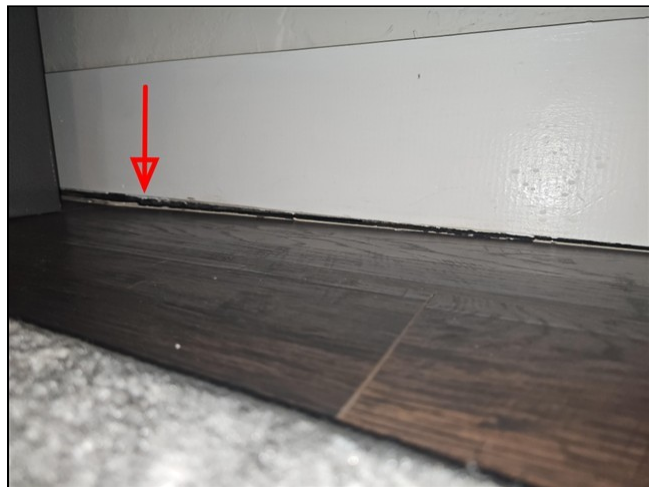
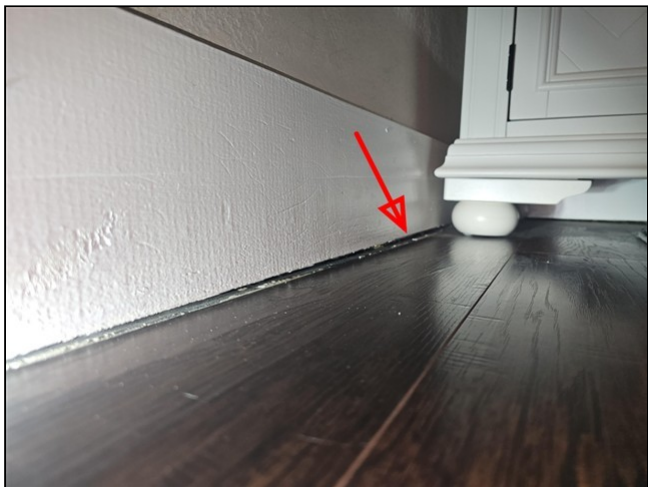
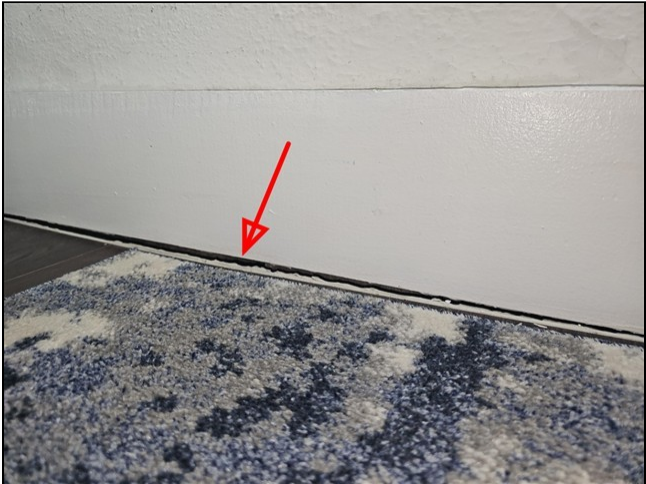
floor-to-wall separation in primary bedroom (left side of home)

floor-to-wall separation in guest bedroom (left side of home)

2. Floor-to-wall separation was observed in the bedrooms on the left side of the home. The floor was sagging here and appeared to have settled in certain locations, likely due to a deficiency in the foundation.

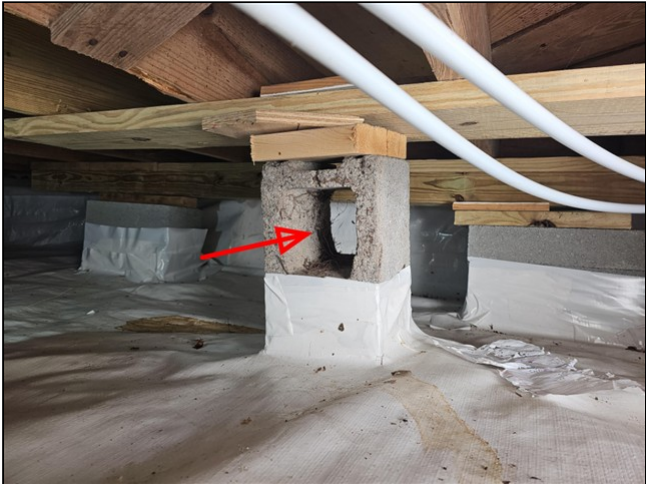
open cores should be vertically oriented

3. One CMU pier was improperly oriented which may compromise its ability to bear weight. CMU piers should be oriented such that the open cores face upward.

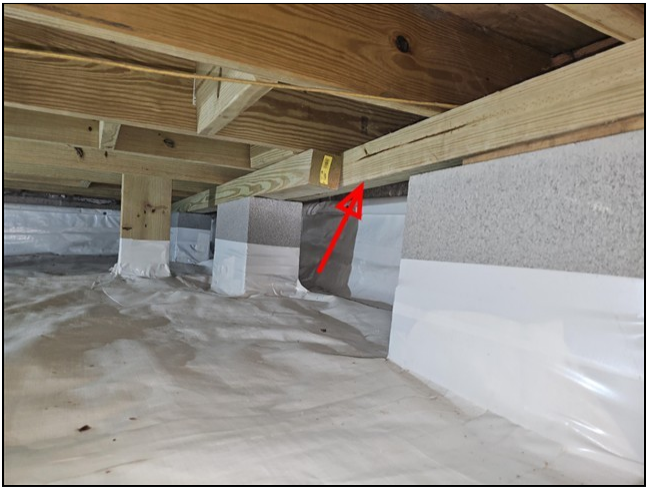
apparent foundation repairs: recommend acquiring documentation from seller

4. It was apparent that past repairs were made to the foundation. Recommend that you acquire documentation of the repair from the seller to obtain any transferable warranty that may exist.

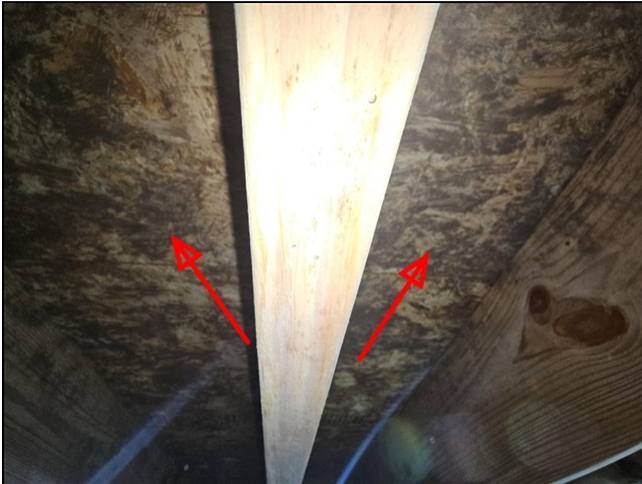
**1.1 Observation:** Possible mold-growth on sub-floor within crawlspace.

**Comment:** The affected area encompassed the sub-floor beneath the living and dining rooms (front-right corner). The sub-floor in this area was comprised of OSB, which is more susceptible to moisture damage than other types of materials. The photo represents a small sample of the flooring that was affected. The presence of mold can only be confirmed via laboratory testing.

apparent mold growth on OSB sub-floor at the front-right corner area within the crawlspace

1. A certified mold assessor take samples as necessary to confirm/deny the presence of mold.
2. If the assessment confirms the presence of mold, recommend a carpenter replace the affected sub-floor.
3. Following any remediation or repairs, a second sample should be taken by a certified mold assessor to confirm the issue has been resolved.

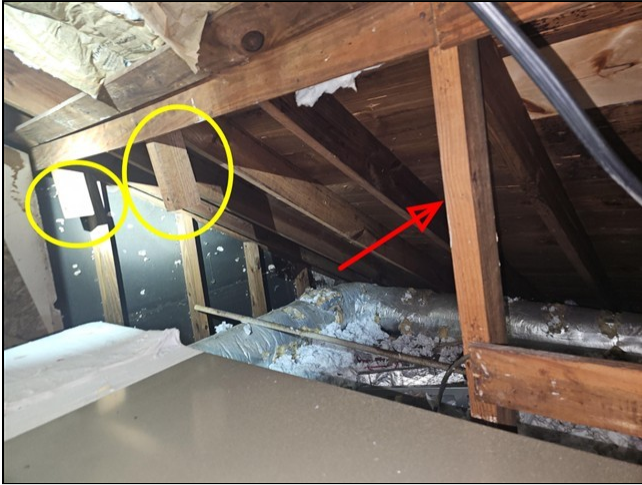
**1.4 Observation:** The roof framing was modified. Two knee-wall studs had been cut/removed, possibly in order to accommodate the air handler.

roof knee-wall bracing was modified in attic

**Recommendation:** Repair by a licensed roofer.

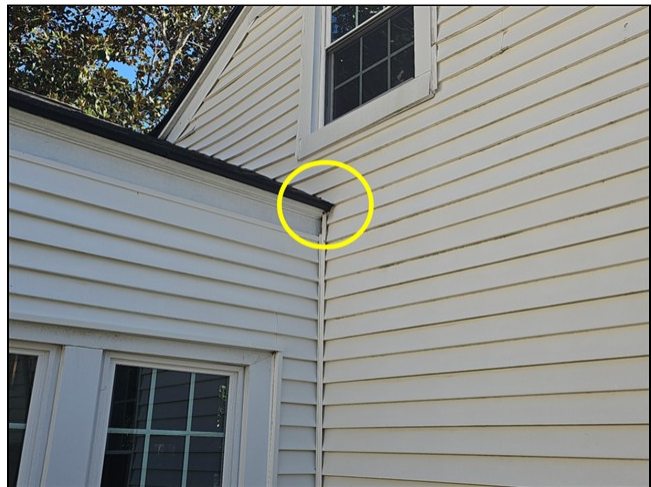
2.1 (1) Observation: A kickout flashing was missing at the referenced location.

Comment: Metal flashings are installed wherever an increased possibility of moisture intrusion may occur. In this case, a kickout flashing should be installed where the exterior sidewall extends beyond the edge of the roof. A kickout flashing will reduce the risk of water damage within this wall.

right side: kickout flashing missing

Recommendation: Kickout flashing installation by a roofing contractor.

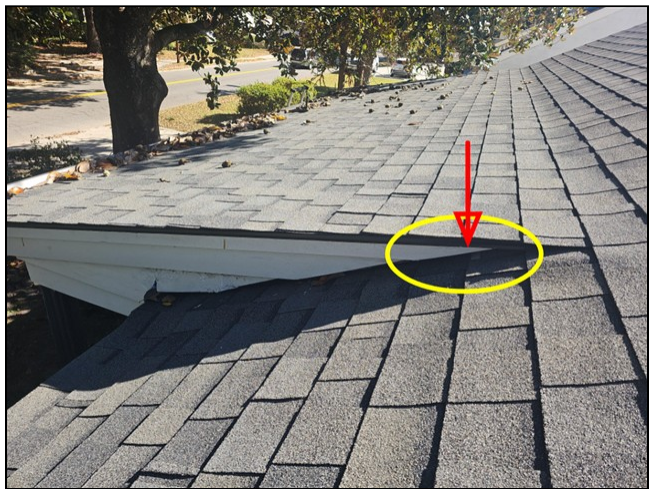
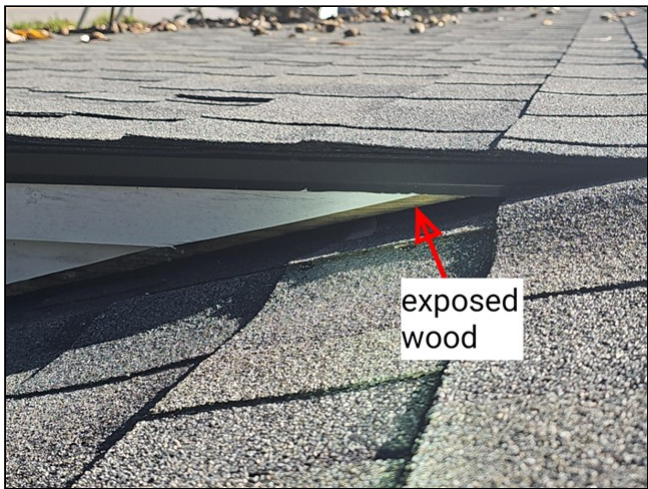
2.1 (2) Observation: Flashing was missing at the referenced location.

Comment: Flashings are installed wherever an increased possibility for moisture intrusion exists. In this instance, wind-driven rain is likely to damage the exposed wood beneath the eave where the two roof slopes intersect. There is also an elevated risk of moisture intrusion here.

flashing missing where at junction of primary roof and front porch overhang

flashing missing where at junction of primary roof and front porch overhang (zoom view)

Recommendation: A licensed roofer install flashing to prevent water damage and leakage at the junction of the primary and sunroom roofs.

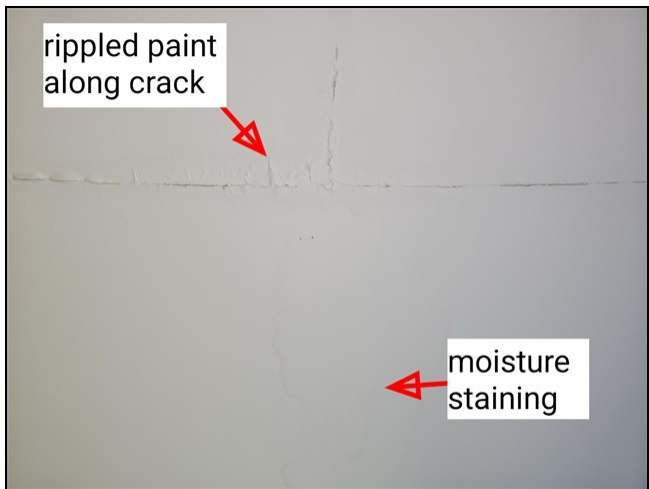
2.3 Observation: There was a crack in the laundry room ceiling, along the edges of which the paint was rippled. Extended downward from the crack (towards the eave) was a moisture stain.

Comment: Due to the vaulted ceiling, this area of the roof was not visible from within the attic, so a roof leak could not be confirmed. The moisture stain was checked with a moisture meter and was dry at the time of inspection.

crack & moisture staining on laundry room ceiling

Recommendation: A licensed roofer evaluate this area for leaks and repair as needed.

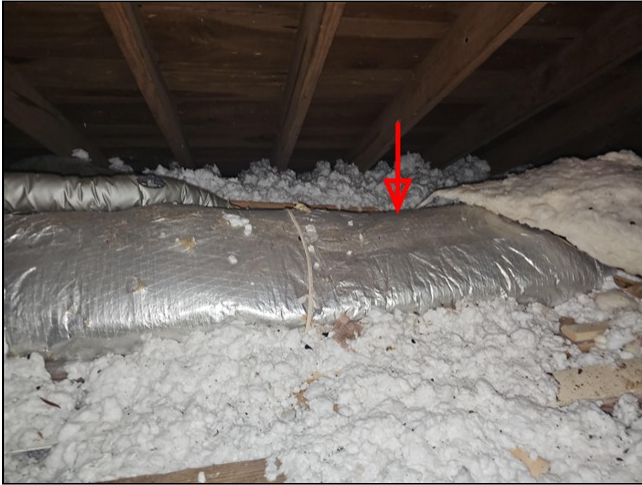
Comment: Pinched or flattened ducts restrict airflow which causes condensation to accumulate. Accumulated condensation will eventually corrode the duct and leak.

flattened, constricted HVAC duct in bonus room attic

Recommendation: Further evaluation and repair or replacement as needed by a licensed HVAC technician.

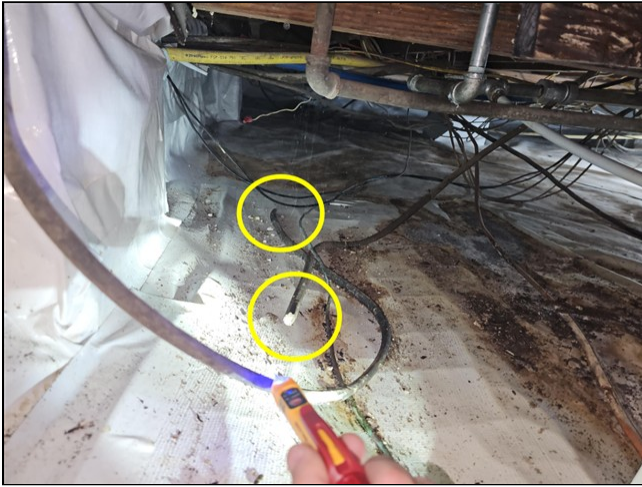
**4.11** (1) Observation: Hazardous electrical wiring in the crawlspace.

Comment: An live (hot) cloth-coated wire was cut and laying on the floor of the crawlspace.

hazardous electrical wiring in crawlspace

Recommendation: Repair by a licensed electrician.

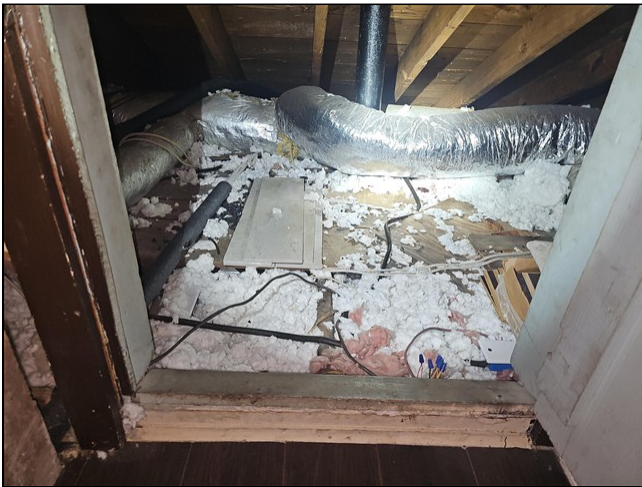
**4.11 (2) Observation:** At the attic entrance, electrical wiring was precariously located atop joists, insulation, and flooring. Individuals entering or storing items in the attic here may damage the wiring.

electrical wiring was precariously installed at attic entrance

Recommendation: A licensed electrician clean up the branch circuit wiring at the attic entrance to reduce the risk of future damage.

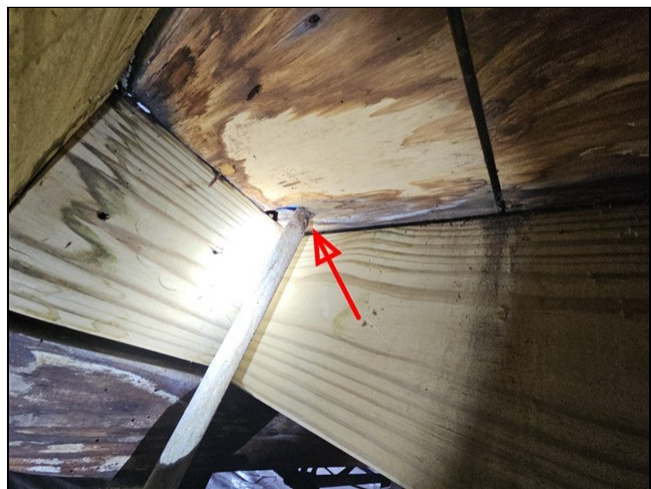
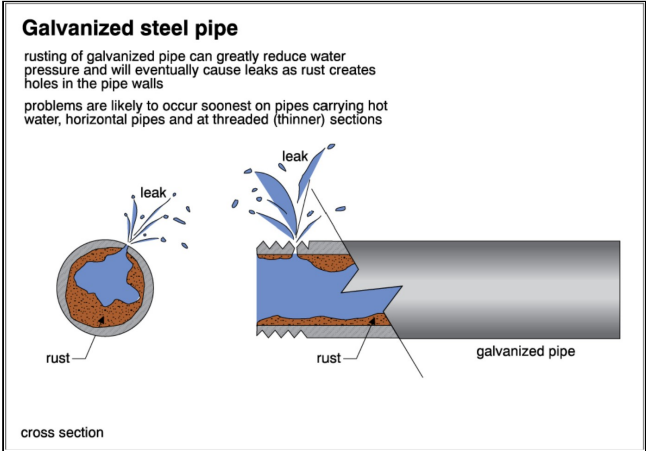
**5.1 Observation:** Some of the visible water supply lines in the home were galvanized, which has an average life expectancy of 50-80 years. In one instance (pictured), the galvanized pipe was corroded and there was moisture staining on the sub-floor surrounding it.

**Comment:** Galvanized piped were installed in homes from the late 19th to mid-20th century. These pipes can rust from the inside out, and gradually corrode, closing up the inside pipe diameter. If the water pressure in the home seems to be getting lower, or there are visible rust or metal fragments in the water, this could be an indication of interior corrosion. Eventually, these pipes may leak, and if inside walls or ceilings, can cause significant damage.

corroded galvanized water supply pipe  
surrounded by moisture-stained wood

galvanized steel pipe

**Recommendation:** A licensed plumber evaluate the condition of the home's galvanized steel water supply lines and repair or replace as needed.

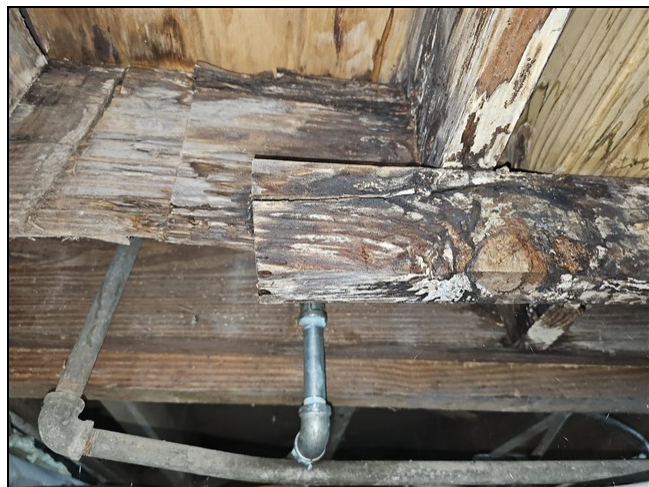
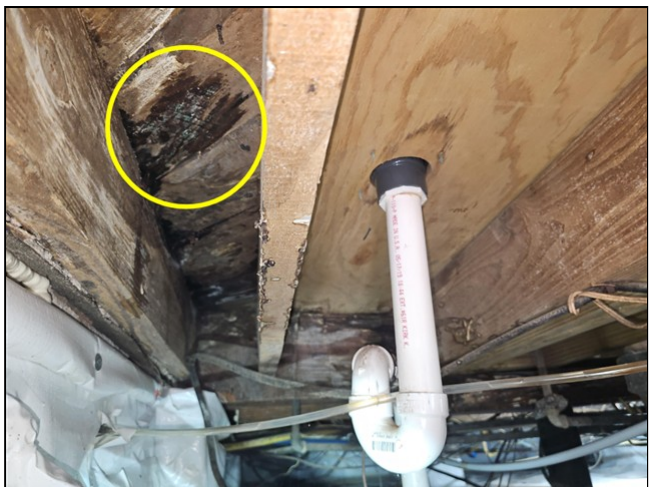
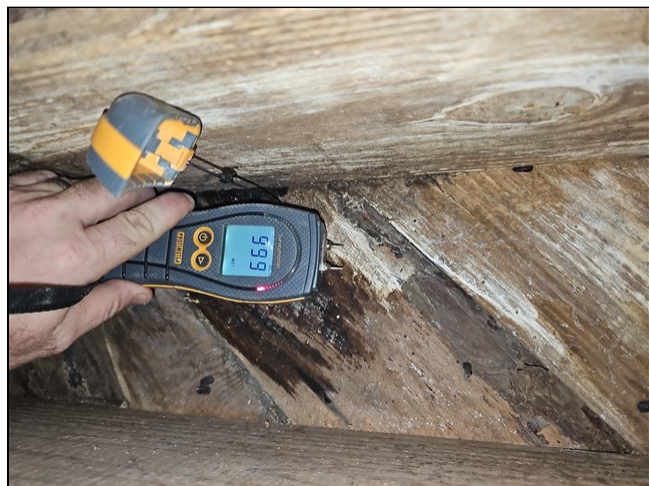
5.2 (1) Observation: A bathroom leak had caused moisture damage to sub-floor and sub-floor framing.

Comment: The specific location of the leak could not be identified. Given the nature and extent of damage, it appeared the leak had occurred for an extended period of time. Newer sub-floor in some surrounding areas may suggest past repair attempts.

water damage to sub-floor framing due to leak beneath bathroom

moisture-staining on sub-floor beneath bathroom

elevated moisture levels on sub-floor at areas where there was moisture staining on wood

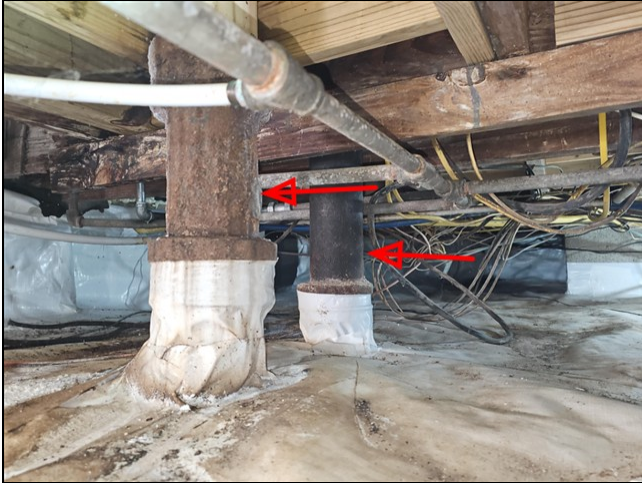
**5.2 (2) Observation:** The presence of outdated cast iron drain pipes.

**Comment:** Cast iron drains were installed prior to the 1970s and have an average service life of 50 to 100 years. Cast iron drains corrode from the inside out which compromises their integrity and reduces the diameter which impedes drainage.

older cast iron drains; recommend sewer scope (standard)

**Recommendation:** A licensed plumber or other qualified professional perform a sewer scope inspection to assess current condition of the home's drains and repair or replace as needed.

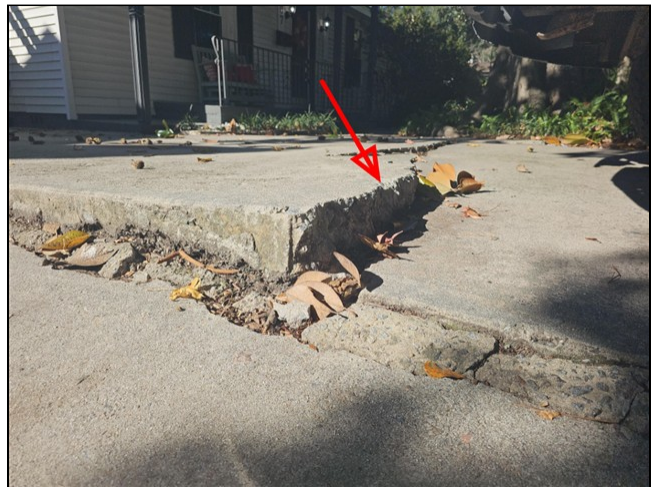
**6.1 Observation:** Significant cracking at the concrete driveway.

Comment: The cracking appeared to have been an ongoing problem and was likely caused by a combination of tree root grown and erosion. The cracks were extensive and created uneven surfaces in multiple locations.

significant cracking in concrete driveway

Recommendation: Repair by a driveway repair or concrete contractor.

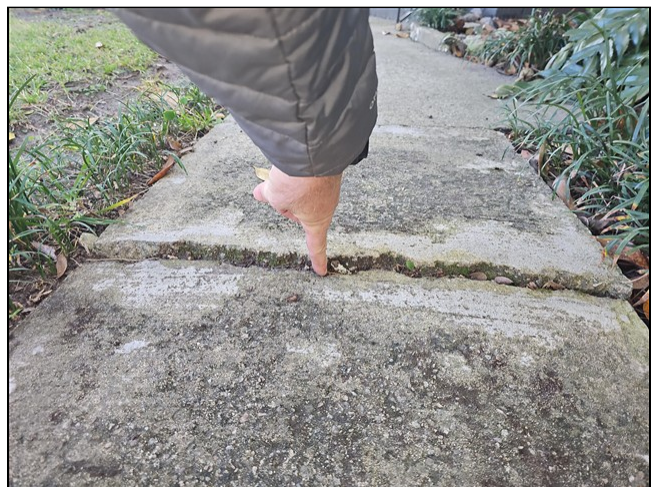
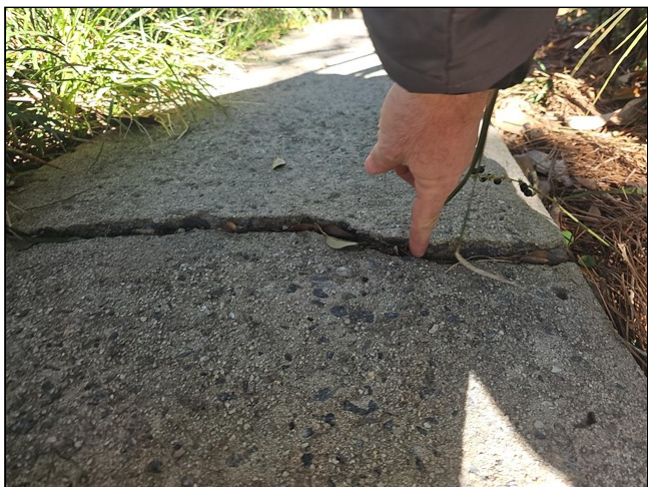
**6.2 Observation:** Offset cracks in the walkway at the referenced locations.

Comment: Offset cracks occur when one side of the crack is higher/lower than the opposing side. Offset cracks are a trip/fall hazard.

offset crack l'm front walkway

offset crack in front walkway

Recommendation: Repair by a concrete specialist.

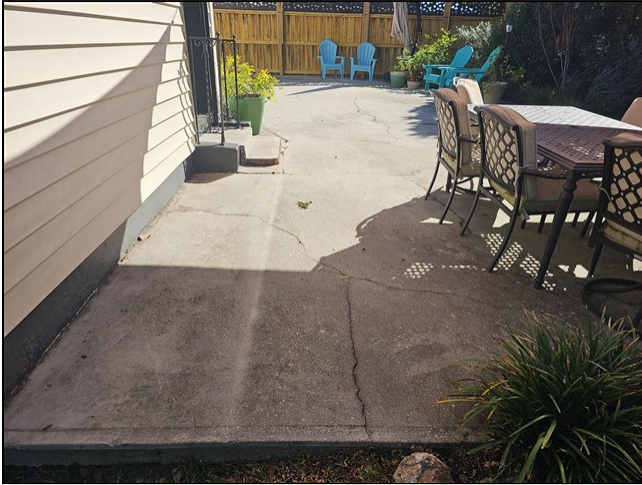
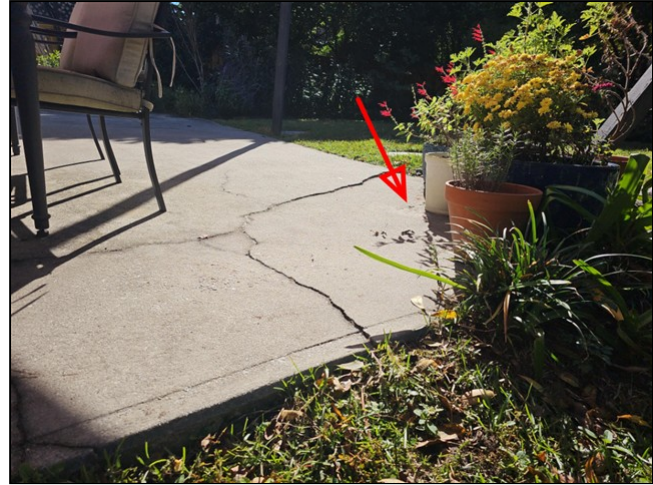
**6.4 Observation:** Cracking of marginal concern on the concrete patio. One corner appeared to be

Comment: Concrete cracks are fairly typical, normally innocuous, and can be caused by a variety of environmental factors during or after installation. The cracks here were likely due to erosion and tree root growth over time.

widespread cracking in concrete patio

patio: corner of concrete slab cracked & settling

Recommendation: Further evaluation and repair as needed by a concrete contractor.

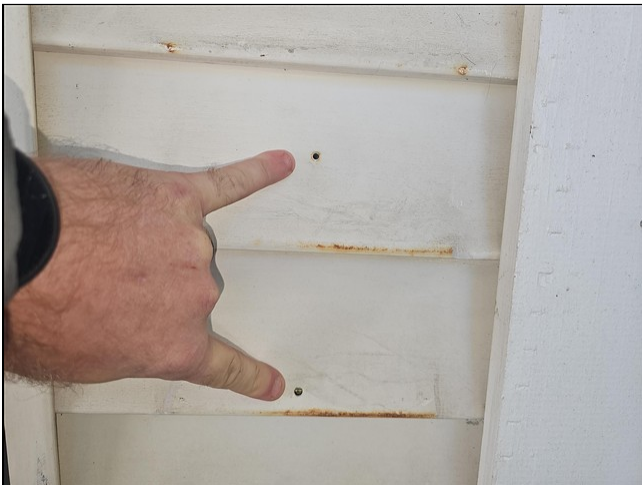
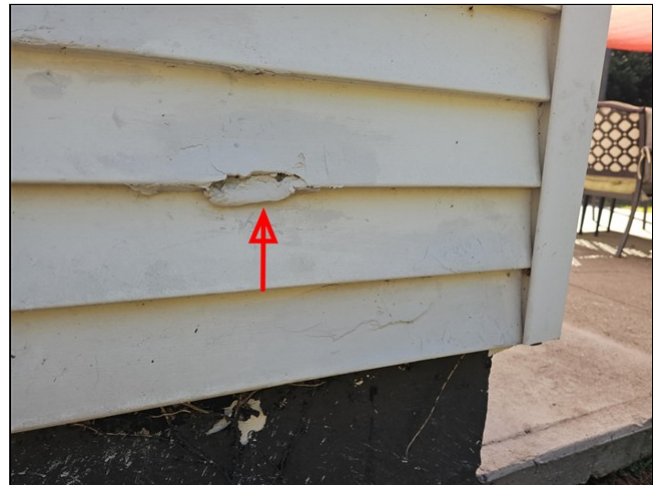
**6.6** Observation: Unsealed holes and minor damage to the siding at the referenced locations.

unsealed holes in siding at front porch

minor siding damage at right-rear corner

Recommendation: Repair by a siding specialist.

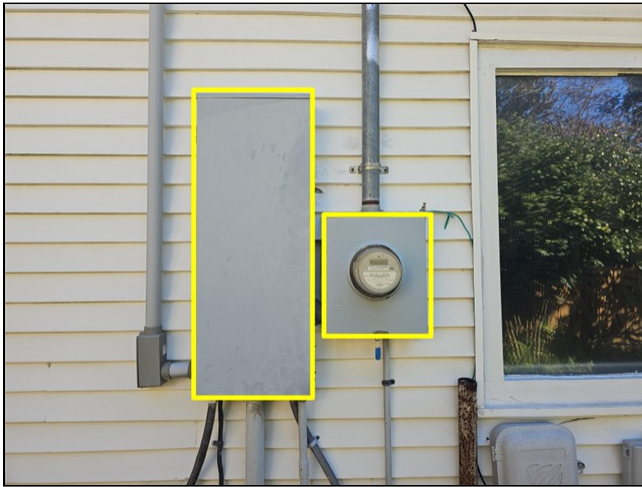
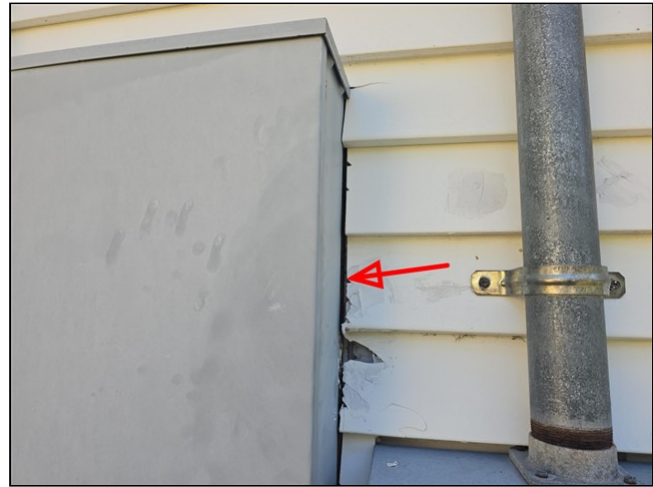
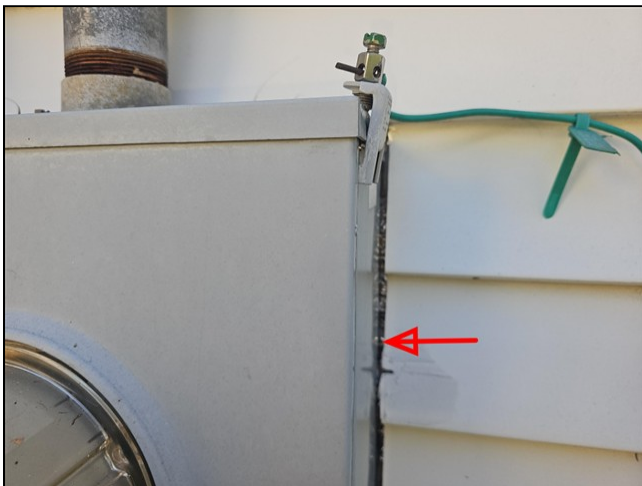
**6.7** Observation: The exterior wall was poorly sealed against moisture intrusion where the service panel and meter were installed.

edges of service panel & meter were not sealed to prevent moisture intrusion

unsealed edges

Recommendation: A siding specialist install drainage provisions (j-channels) around the edges, or use other approved methods as needed, to prevent moisture intrusion.

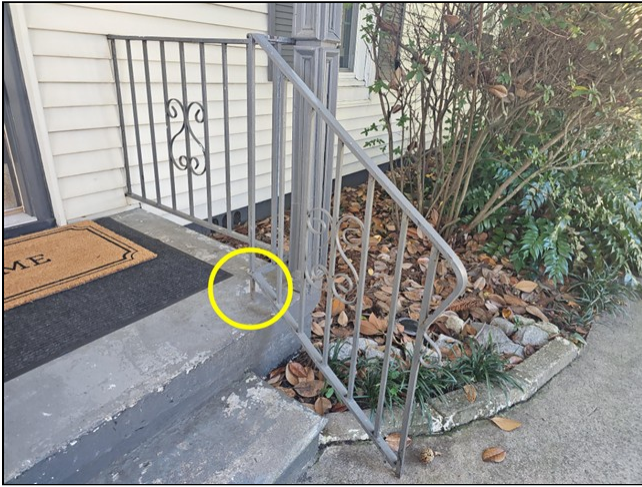
**6.10 Observation:** A loose handrail at the front porch due to a detached post.

front porch: railing post base was detached,  
railing was loose

Recommendation: Repair or replacement as needed by a qualified contactor.

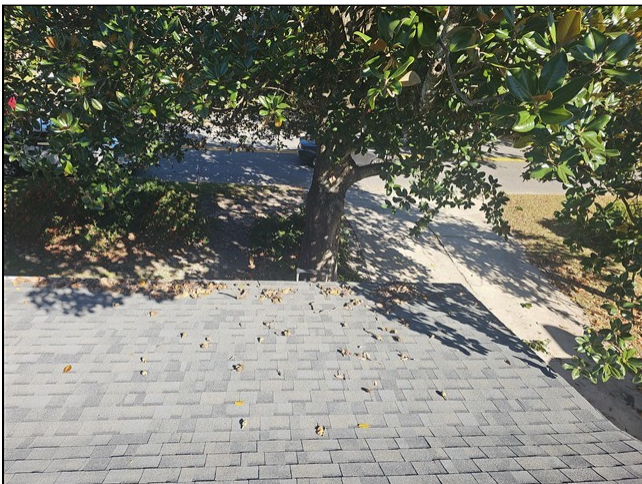
**6.11** Observation: Tree debris had accumulated on the roof over the front porch.

tree debris buildup on front porch overhang

1. A qualified professional should remove any debris currently on the roof.
2. A tree expert should trim any limbs hanging over the roof to prevent future occurrences.

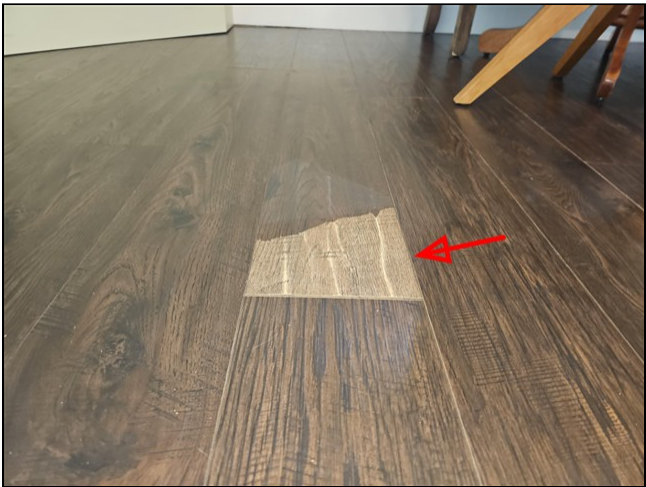
**7.0** Observation: A floor plank was delaminated in the kitchen.

delaminated flooring in kitchen

Recommendation: Repair by a flooring specialist.

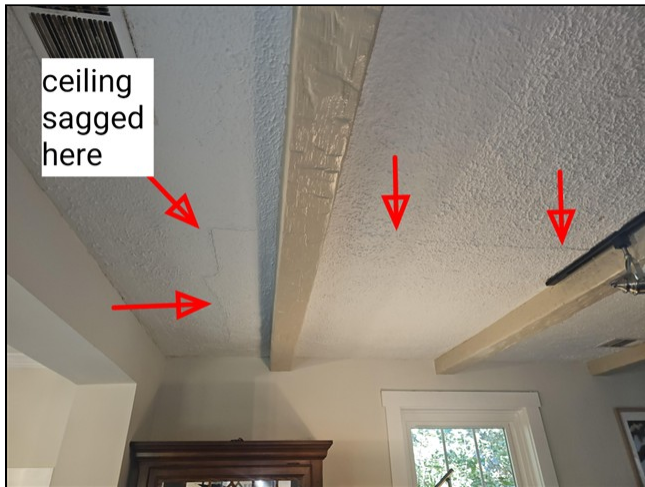
**7.2** Observation: There was widespread ceiling cracking throughout the home.

- The ceiling in the living room sagged along the crack where indicated.

living room ceiling: sagged & cracked

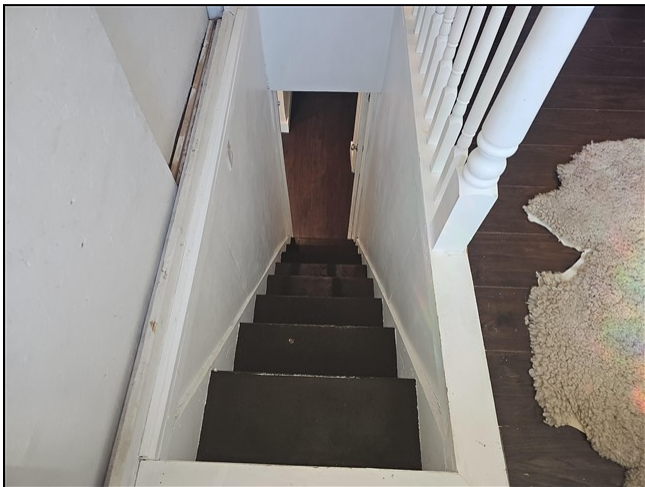
**7.6 (1) Observation:** A handrail was not installed on the stairs leading to the bonus room.

handrail not installed

**Recommendation:** Handrail installation by a carpenter.

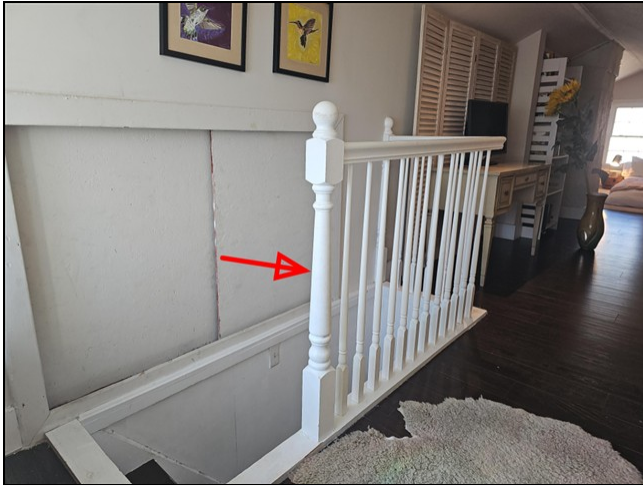
**7.6 (2) Observation:** A loose newel post resulted in a loose railing atop the staircase in the bonus room.

loose newel post at upstairs railing

**Recommendation:** A carpenter anchor the newel post properly such that the railing feels secure when handled.

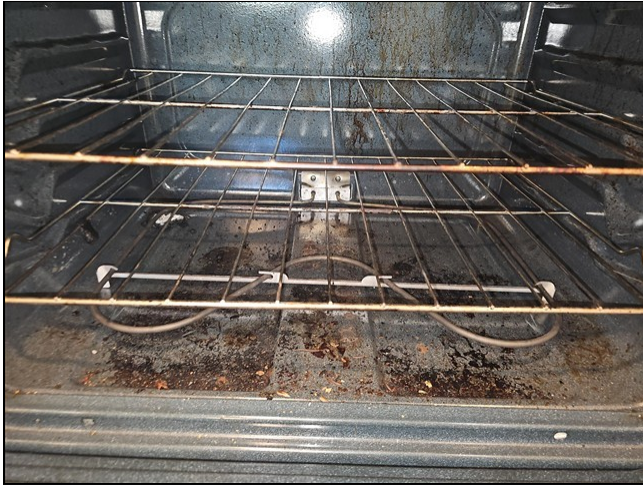
**8.1** Observation: Food & grease buildup within the oven.

inside of oven was dirty

Recommendation: Have the oven cleaned prior to closing.

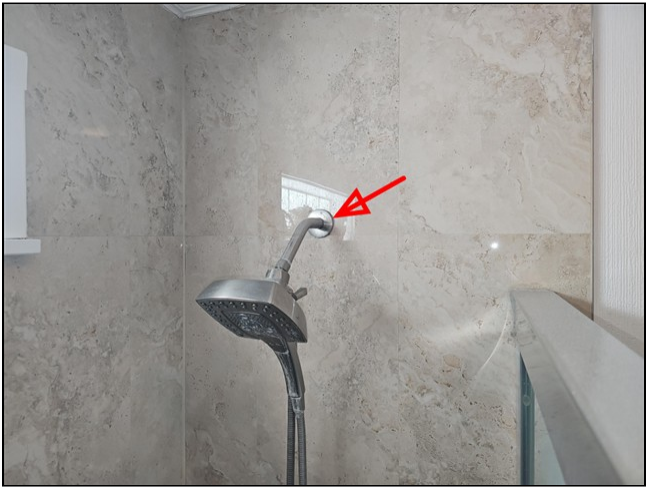
**9.0 Observation:** A loose shower head stem.

Comment: The shower head stem moved easily when handled.

loose showerhead stem

Recommendation: Repair by a licensed plumber.

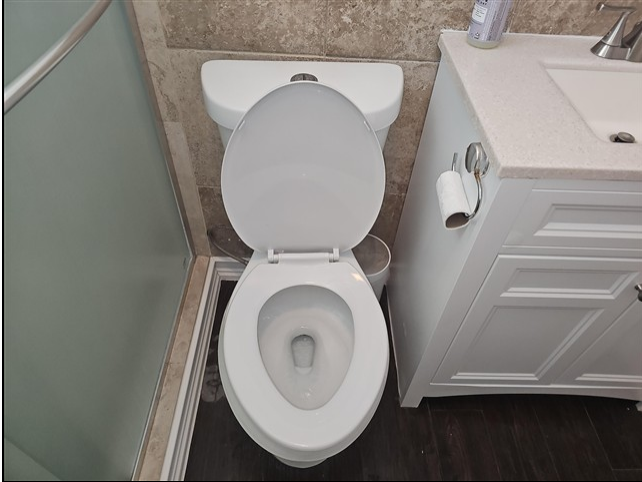
**9.1 Observation:** A loose toilet at the referenced location.

**Comment:** Loose toilets may be caused by improperly torqued anchor bolts or a degraded wax ring seal.

bathroom: loose toilet

**Recommendation:** Repair by a licensed plumber.

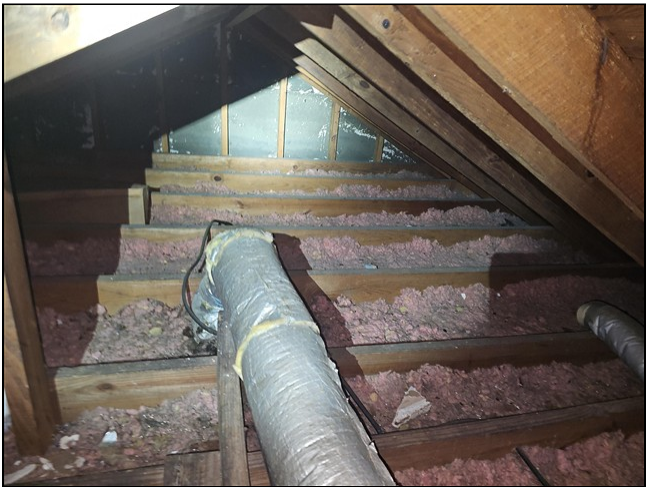
Comment: Compaction is a natural occurrence; however, compacted insulation is not as effective at preserving interior temperatures in this state.

compacted blown-in fiberglass insulation in the attic

Recommendation: An insulation contractor replace or amend the attic insulation where needed.

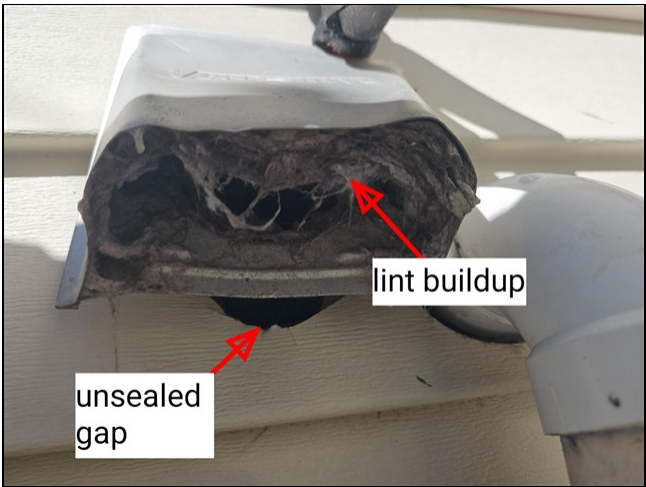
dryer vent was clogged & poorly sealed where it exited the wall

- 1. Clean the duct and vent so the damper closes and seals properly.
- 2. A qualified contractor should seal the gaps around the duct where it exited the wall.

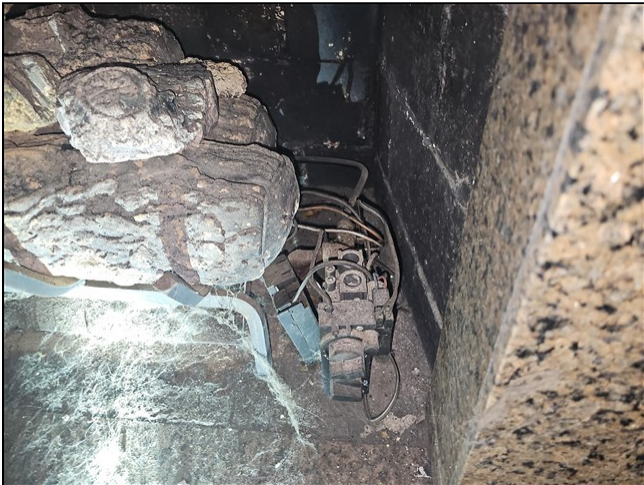
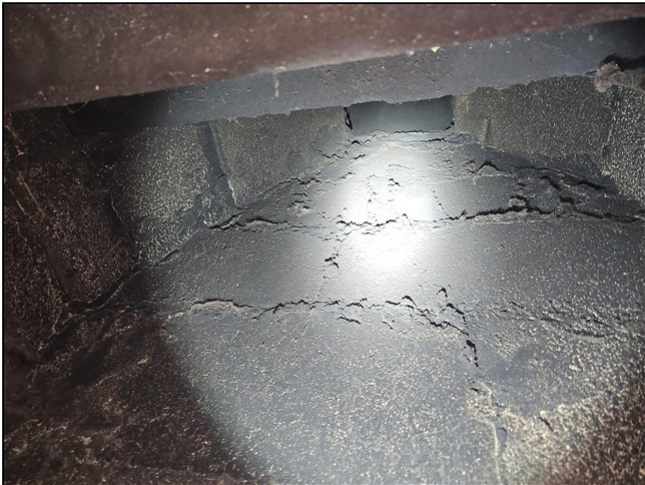
**12.0 Observation:** A wood-burning fireplace had been retrofitted with a gas burner and logs. The fireplace controls were not operated due to the fact that it had apparently been unused for an extended period along with the following.

1. A bookcase was positioned in front of the fireplace at the time of inspection, indicating the fireplace is not used regularly.
2. There was a marginal buildup of soot or creosote on the interior surfaces of the chimney and flue. Creosote is a highly flammable, tar-like byproduct of burning wood that builds up inside a chimney flue and is bad because it can ignite and cause dangerous chimney fires. Soot, on the other hand, is a dry, powdery like substance that indicates incomplete combustion.

older fireplace controls that appear to have been unused for an extended period

chimney flue had marginal buildup

1. A licensed chimney sweep clean the flue to remove soot/creosote.
2. A fireplace technician test the function of the gas logs, controls, and burner ribbon. Repair as needed.
