INSPECTION REPORT  
1 Main Lane  
Savannah GA 31419

INSPECTED BY  
Keith Ware  
Pride Home  
Inspections, LLC

INSPECTION DATE  
📅 11/11/2025  
🕒 09:40 AM

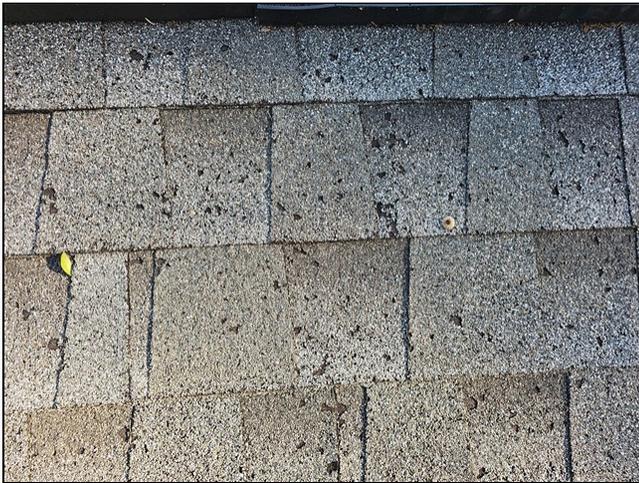
**2.0 Observation:** There was widespread hail damage on the roof covering which compromised the shingles' ability to shed water. The photos are not all-inclusive but are representative of the general condition.

hail damage on shingles

1. Shingle replacement by a licensed roofer.
2. Insurance may be responsible for all or a portion of the replacement cost. The seller may contact their insurance provider to submit a claim.

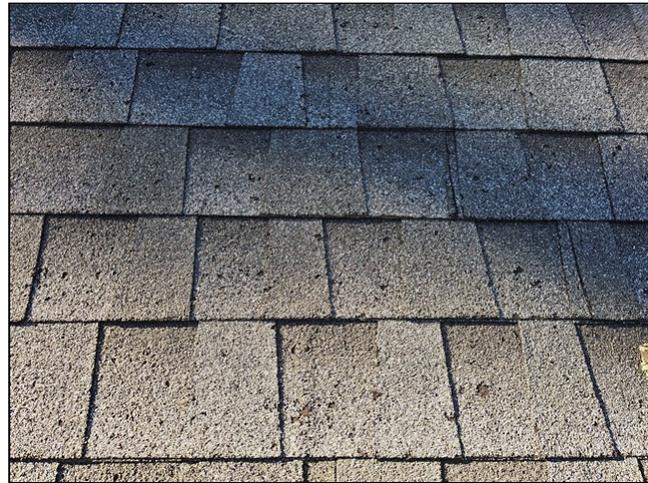
hail damage on shingles

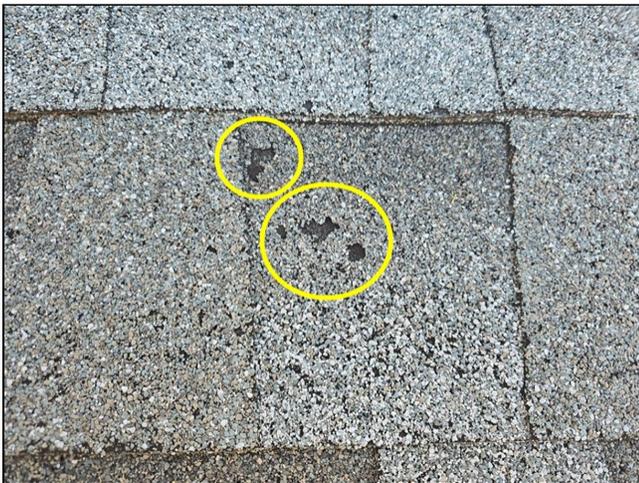
hail damage on shingles (zoom view)

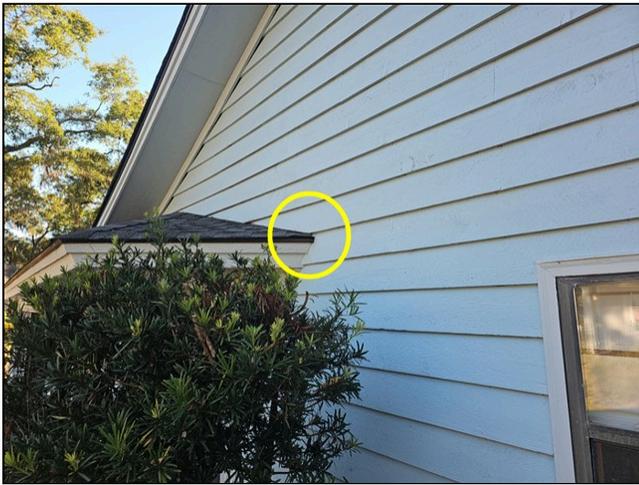
**2.1 Observation:** A kickout flashing was missing at the referenced location.

**Comment:** Metal flashings are installed wherever an increased possibility of moisture intrusion may occur. In this case, a kickout flashing should be installed where the exterior sidewall extends beyond the edge of the roof. A kickout flashing will reduce the risk of water damage within this wall.

right side, above bay windows: missing kickout flashing

**Recommendation:** Kickout flashing installation by a roofing contractor.

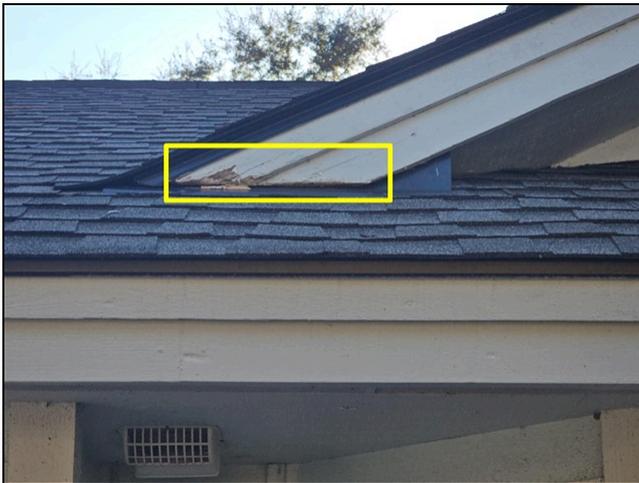
**2.2 Observation:** Minor damage to lower edge of rake board at the referenced location.

minor damage at bottom edge of rake board over garage

**Recommendation:** Rake board repair by a licensed roofer.

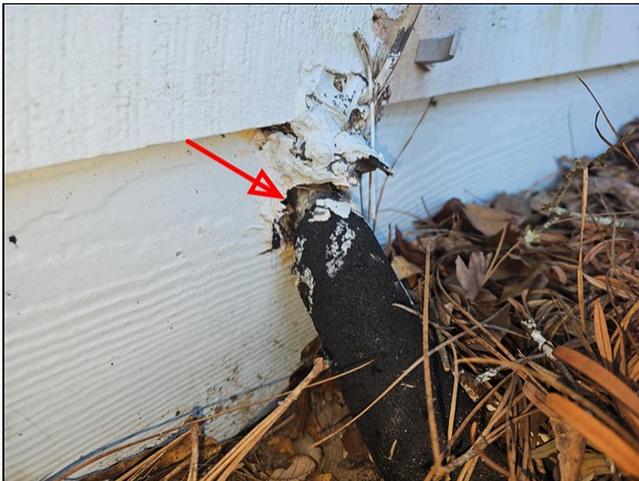
Comment: Poorly sealed exterior wall penetrations increase the risk of water intrusion and damage. Sealant was applied, but sealant dries, shrinks, and cracks over time and must be reapplied regularly. An HVAC Wall Penetration & Line-Set kit ensures a weatherproof seal for an extended period of time.

no insulation on refrigerant line where it entered the wall & unflashed exterior wall penetration

1. An HVAC technician install an HVAC Wall Penetration & Line-Set kit to eliminate the need to inspect and repair degraded sealant periodically.
2. If this is not feasible, recommend an HVAC technician repair the degraded sealant. Check the sealant periodically (annually) to ensure there are no gaps and repair or replace sealant as needed at that time.

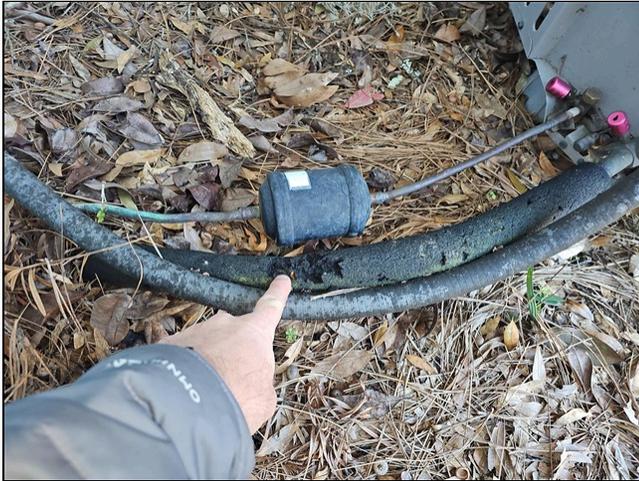
**3.1 (2) Observation:** The refrigerant line insulation sleeve was degraded at the exterior unit.

degraded insulation on exterior section of refrigerant line

**Recommendation:** A qualified professional replace the refrigerant line insulation.

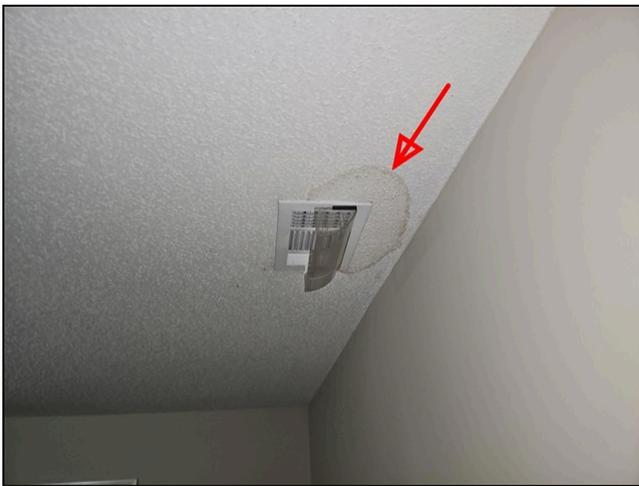
**3.2 Observation:** Moisture (condensation) staining surrounding an air supply register at the referenced location.

Comment: The moisture staining may be caused by one or more of the following.

- The unit is run at extremely cold temperatures in a hot, humid environment.
- Inadequate duct insulation around this vent.
- excessive sharp angles in ductwork attached to vent.

guest bedroom: moisture (condensation) stain  
around air supply vent

Recommendation: Further evaluation and repair as needed by a licensed HVAC technician.

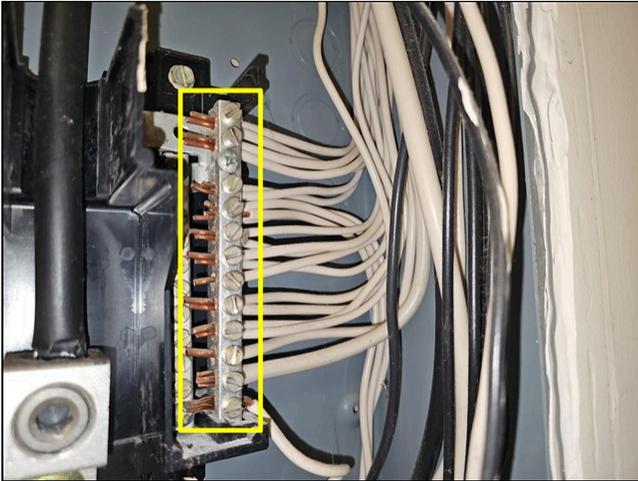
Comment: There should be only one neutral wire per lug to prevent hazards, as having multiple wires can lead to loosened connections, arcing, and potential over-voltage conditions when a breaker is switched off, especially in a multi-wire branch circuit. Each neutral wire requires its own secure terminal to ensure the return path of current for its specific circuit.

sub panel: multiple lugs were overloaded on neutral bus bar

Recommendation: Repair by a licensed electrician.

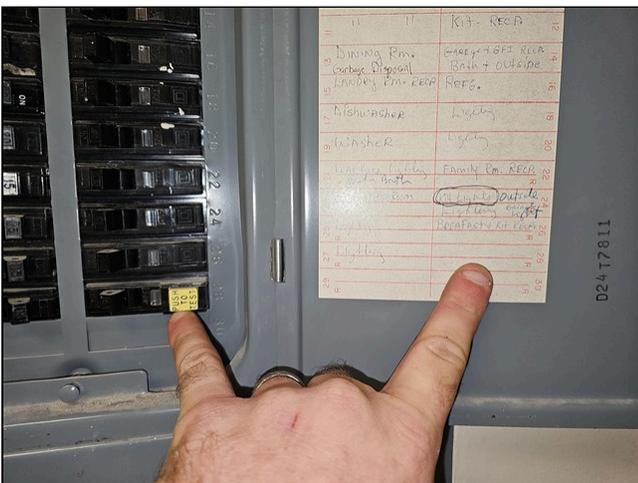
**4.5 (2) Observation:** One unlabeled circuit breaker at the interior panel.

sub panel: breaker #28 was not labeled

Recommendation: A licensed electrician identify and label the breaker for future reference.

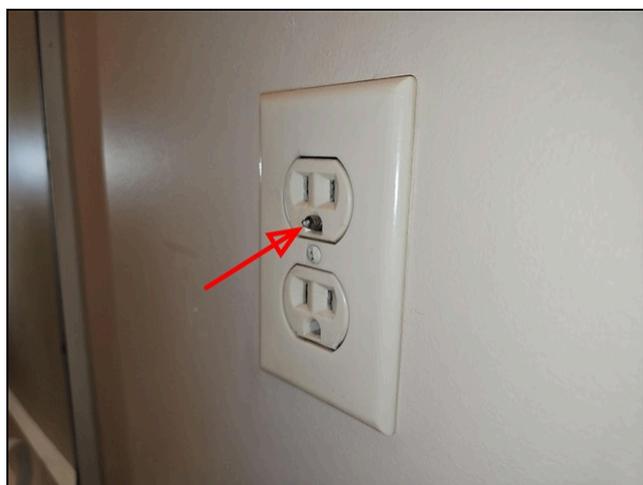
**4.7 (2) Observation:** A prong was lodged in the ground slot at the electrical receptacle in the hall bathroom.

hall bathroom: ground prong lodged in receptacle

Recommendation: Repair by a licensed electrician.

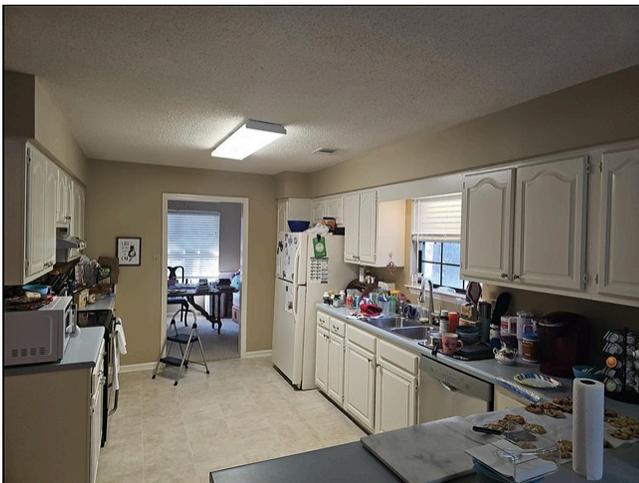
**4.9 (1) Observation:** There was no functional GFCI (ground fault circuit interrupter) protection installed at any of the locations that are required by current electrical standards. In some cases, GFCI-enabled receptacles were installed, but defective.

no GFCI protection at kitchen receptacles

Recommendation: Repair by a licensed electrician.

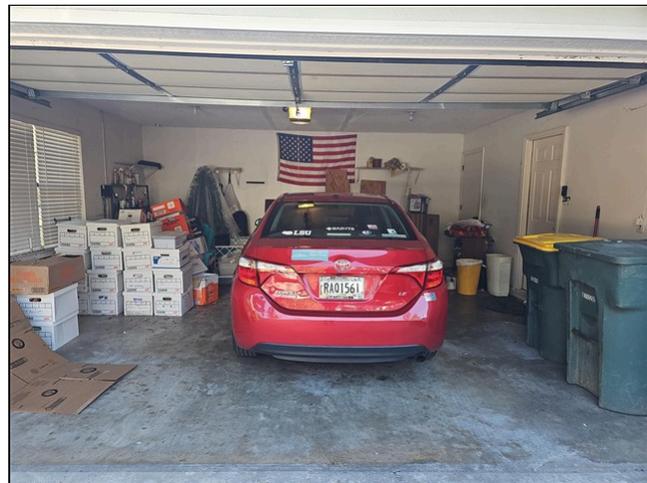
deficient GFCI protection at garage receptacles

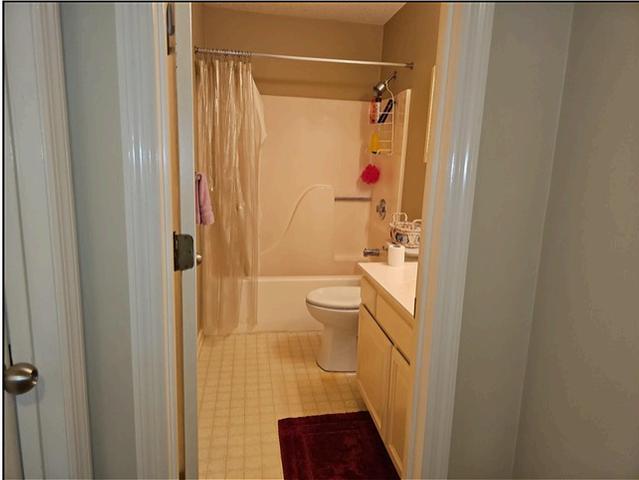
no GFCI protection in hall bathroom

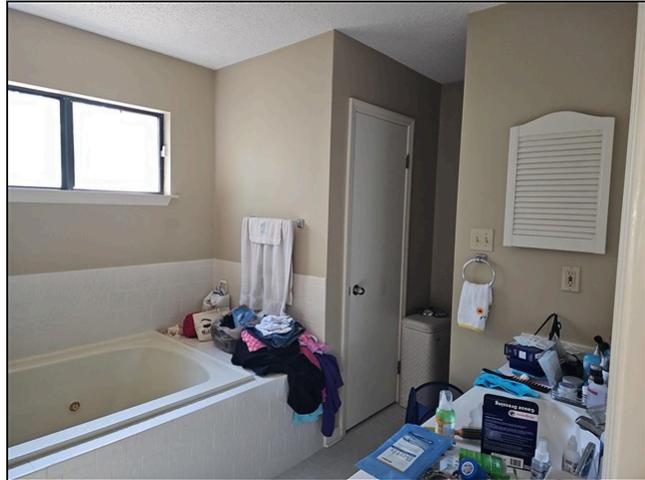
deficient GFCI protection in primary bathroom

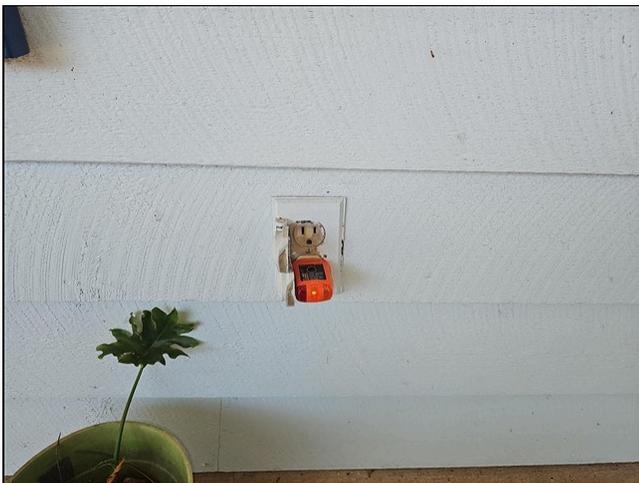
deficient GFCI protection at exterior receptacles

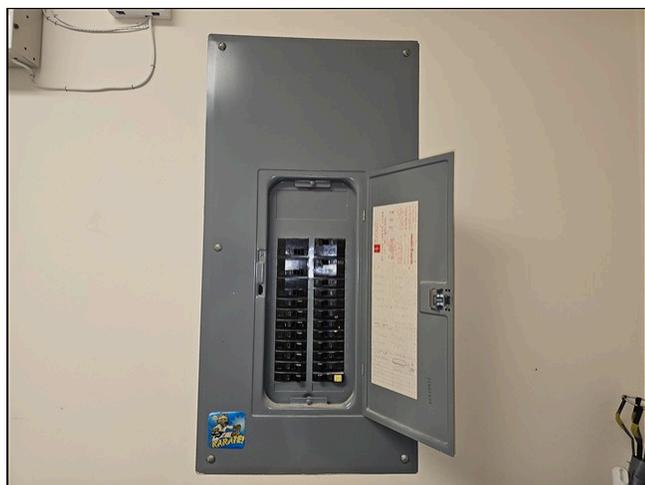
**4.9 (2) Observation:** There were no AFCI (Arc Fault Circuit Interrupter) breakers installed. AFCI protection is a current requirement for all bedroom branch circuits.

AFCI breakers were not installed at bedroom circuits

**Recommendation:** Although AFCI protection may not have been a requirement at the time of construction, it may be prudent to have them installed as an added layer of protection against electrical fire. AFCI protection is often established by installing AFCI-protected breakers in the service or sub panel at all bedroom branch circuits.

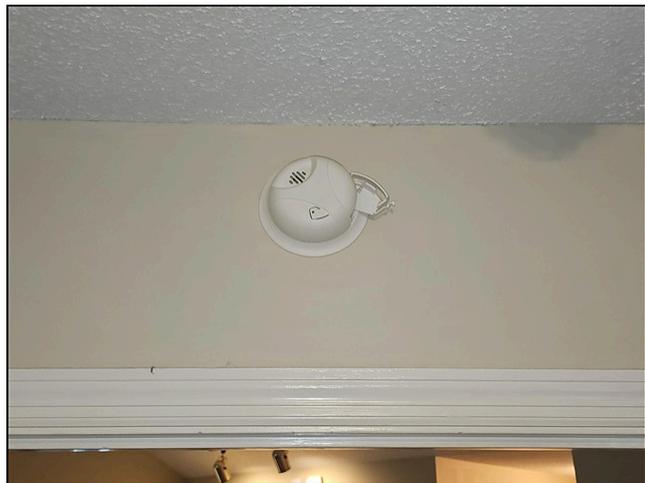
**4.11 Observation:** Missing and/or dead smoke detector batteries.

smoke detector battery removed in primary bedroom

**Recommendation:** Replace batteries in and test all smoke detectors for proper operation using the "test" button on the device.

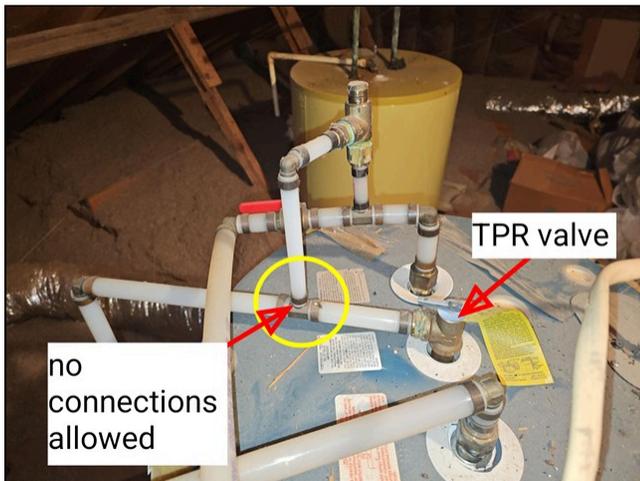
**Comment:** The TPR valve drain line was connected to the whole-home pressure relief valve drain line. A TPR valve is a safety device on a water heater that releases excess pressure or temperature to prevent the tank from bursting. It automatically opens when the water inside exceeds safe limits (typically 150 psi or 210°F) and releases water and steam through a discharge pipe. This prevents damage and ensures the safety of the water heater and those around it. The TPR drain line should not share a connection with any other drain lines.

TPR drain line was improperly installed

**Recommendation:** Repair by a licensed plumber.

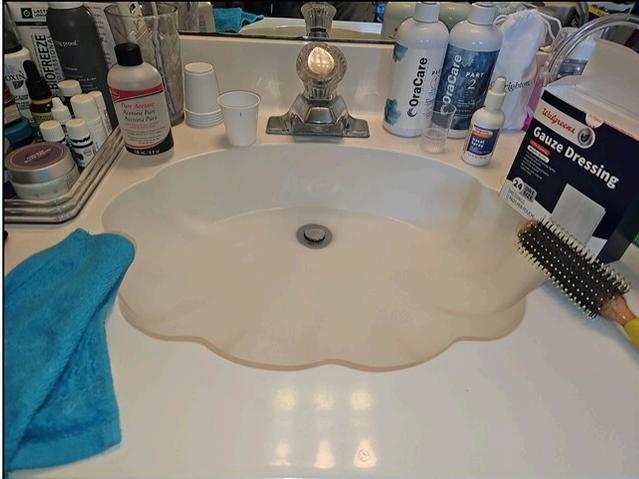
slow drain at primary bathroom sink

Recommendation: Attempt to clear the drain using a 1/4 cup of baking soda followed by 2 cups of vinegar. Allow this to sit in the drain overnight and then run water through the drain. Approved store-bought products may also be used. If this is unsuccessful, recommend contacting a plumber for further evaluation and repair.

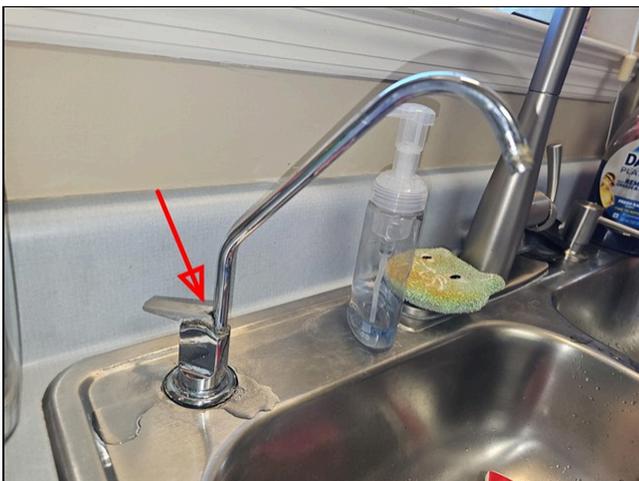
**5.5** Observation: Water leaked from the handle of the water faucet at the kitchen sink.

kitchen sink fixture leaked from handle

Recommendation: Repair or replacement as needed by a licensed plumber.

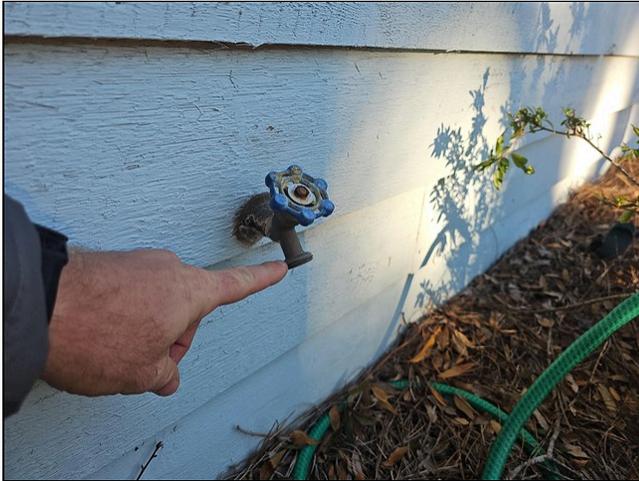
**5.6** (1) Observation: Vacuum breakers were not installed at three exterior hose bibs.

vacuum breakers were not installed at 3 hose bibs

Recommendation: Install vacuum breakers where missing.

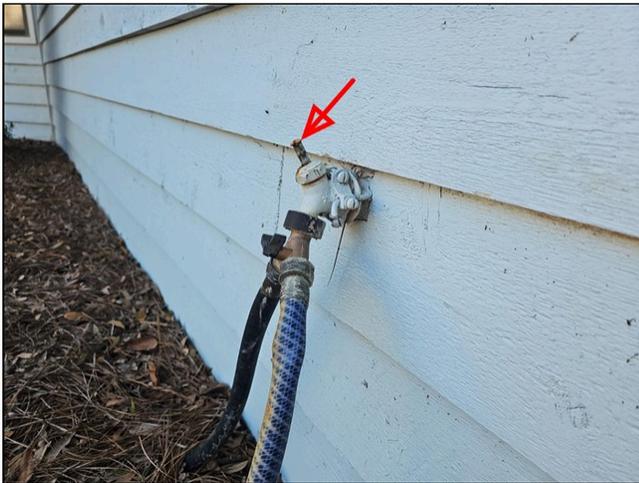
**5.6 (2) Observation:** A missing handle at the hose bib in the wall.

hose bib on right exterior wall: missing handle

Recommendation: Handle installation by a qualified professional.

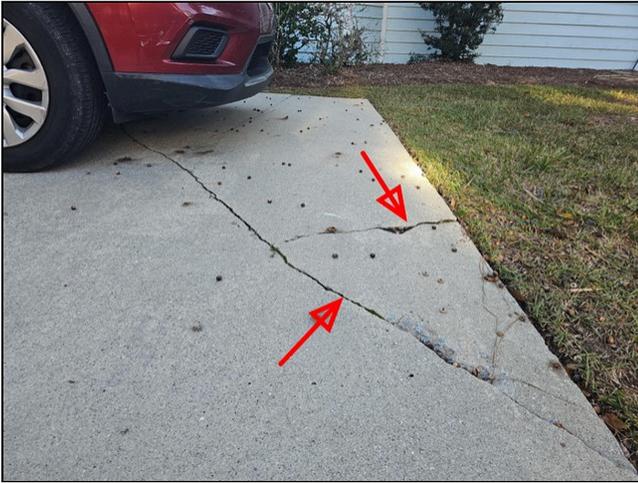
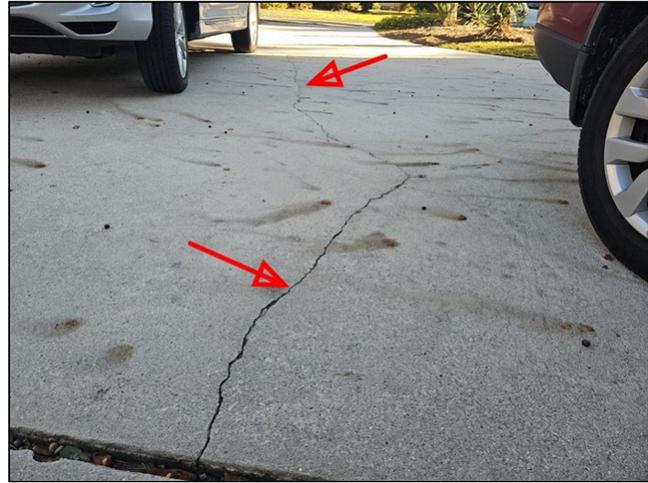
**6.1 Observation:** Cracking of marginal concern on concrete driveway.

Cracks of marginal concern are those that are offset (uneven surface) or wider than 1/8".

marginal cracking on concrete driveway

Recommendation: Repair by concrete or specialized concrete repair contractor.

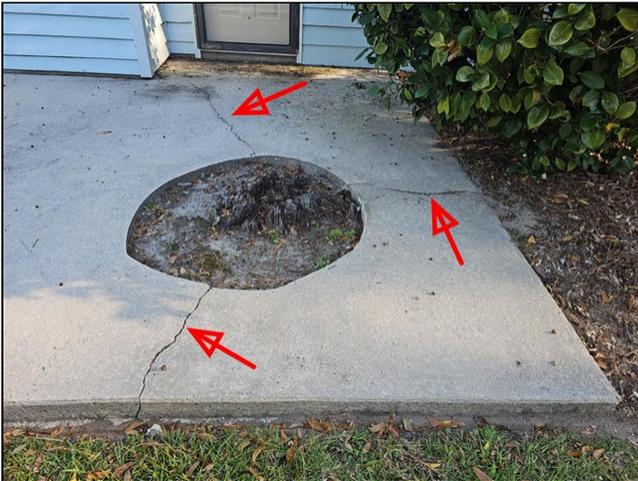
**6.4 Observation**: The concrete slab at the patio had cracked around a void in the slab left to accommodate a tree which has since been removed (except for the stump).

patio: cracked concrete slab

1. A qualified professional remove as much of the stump as possible.
2. A concrete contractor repair the cracked patio slab.

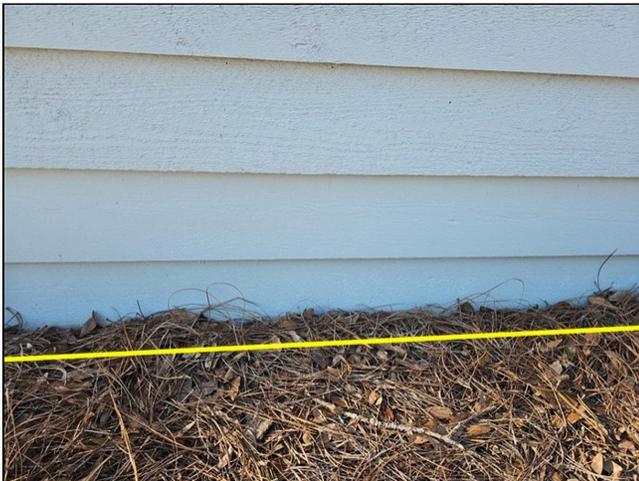
**6.6 (1) Observation**: The mulch was installed too high against the siding which increased the risk of pest damage and moisture-related problems. Possible termite damage was noted on the windowsill in the garage.

mulch installed several inches higher than siding

1. A landscape specialist adjust the mulch around the perimeter such that there is a gap exposing 2-3" of the foundation. Re-grading as required.
2. A siding specialist evaluate the condition of the lower courses of siding and replace where damaged.
3. A licensed pest control technician evaluate for possible termite damage at the garage windowsill and treat accordingly. Recommend acquiring documentation from the seller if past treatments have been performed.

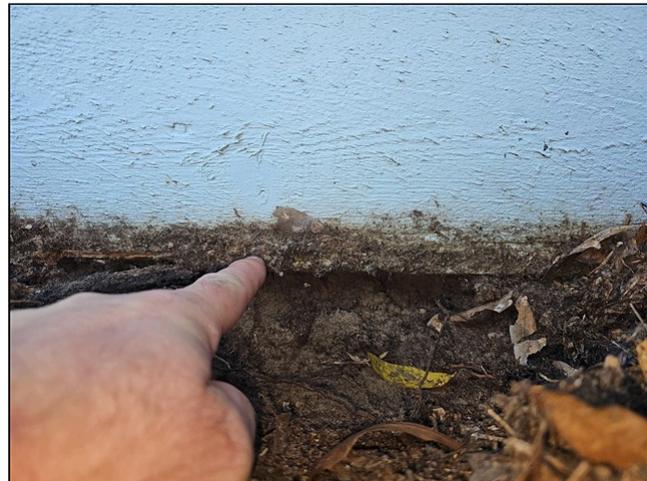
Comment: The bottom edge of the siding was saturated and brittle due to prolonged moisture

bottom edges of lowest course of siding were brittle due to prolonged exposure

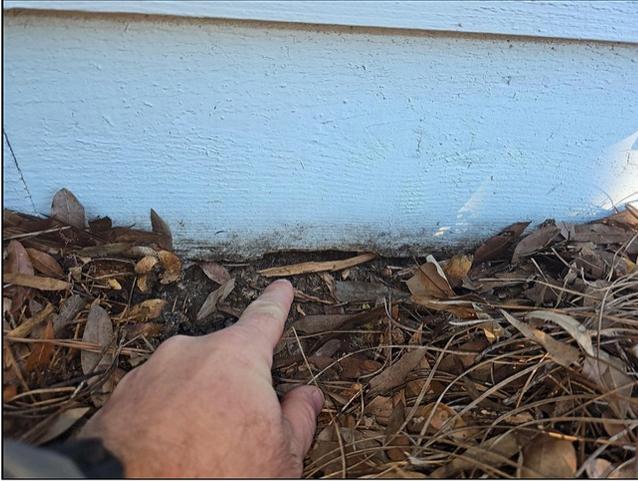
exposure. The wood siding had been replaced with cementitious siding in multiple locations and apparently due to this condition.

lower edges of wood siding were degraded due to prolonged moisture exposure

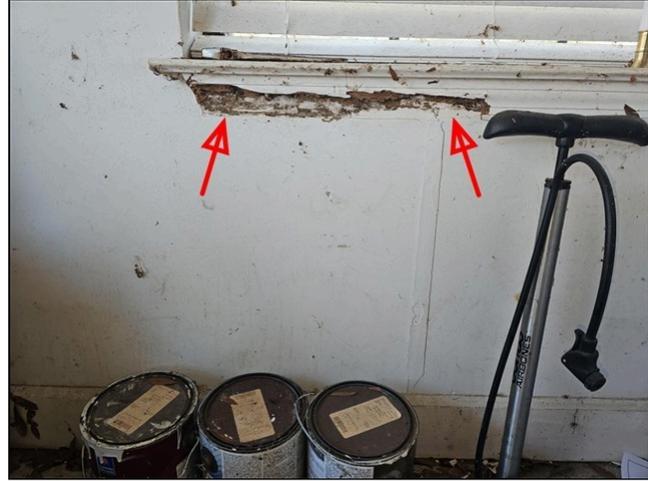
There were indications of apparent termite damage to the window sill in the garage. In addition to exposing the wood to moisture damage, termites and pests will use the mulch as a bridge to travel from the soil to the wooden structure.

apparent termite damage to windowsill in garage

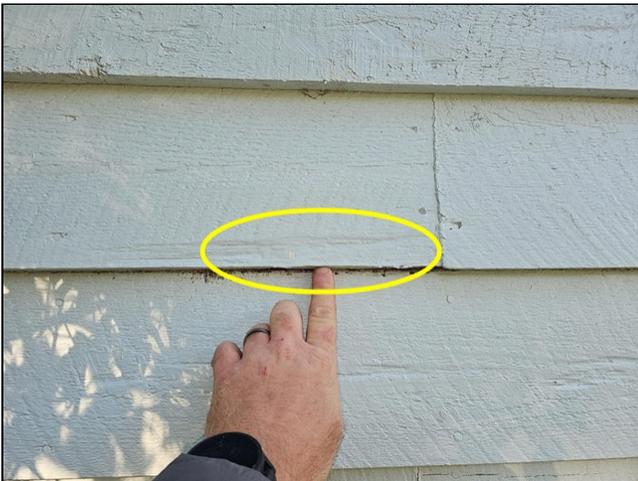
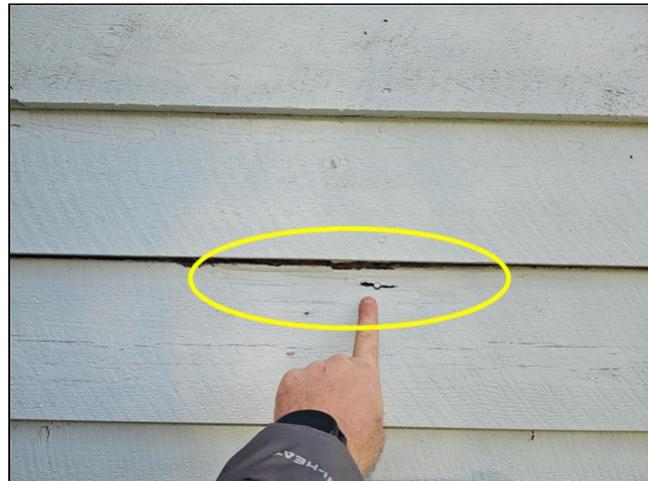
**6.6 (2) Observation:** The wood siding was in generally serviceable condition but found dry-rotted in multiple locations due to unsealed butt-joints, cracks, and nail heads.

left exterior wall: dry-rotted siding

1. A siding specialist evaluate the siding and repair or replace dry-rotted siding as needed.
2. A professional painter caulk gaps and seams and repaint siding.

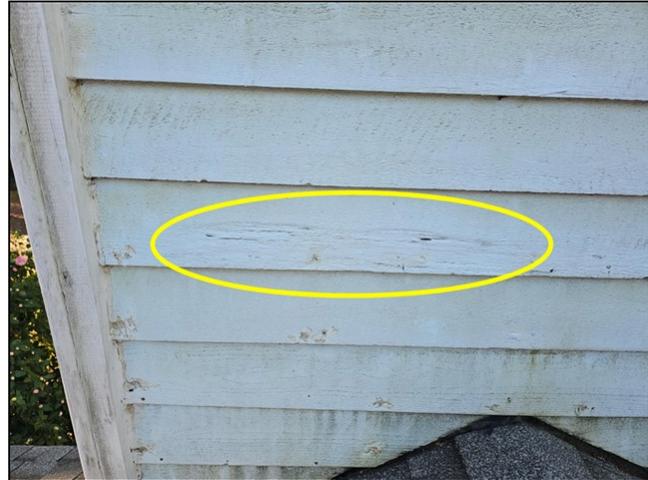
dry-rotted siding on chimney

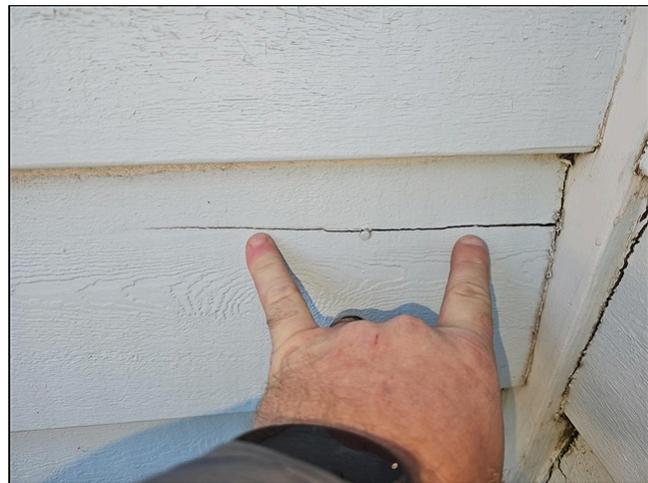
uncaulked crack

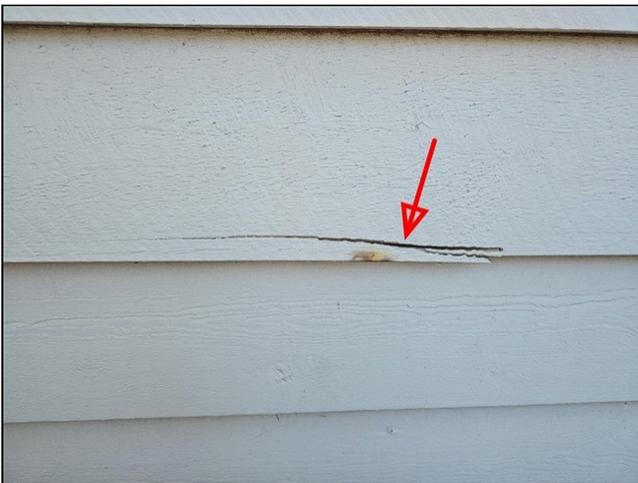
splintered siding at rear exterior wall

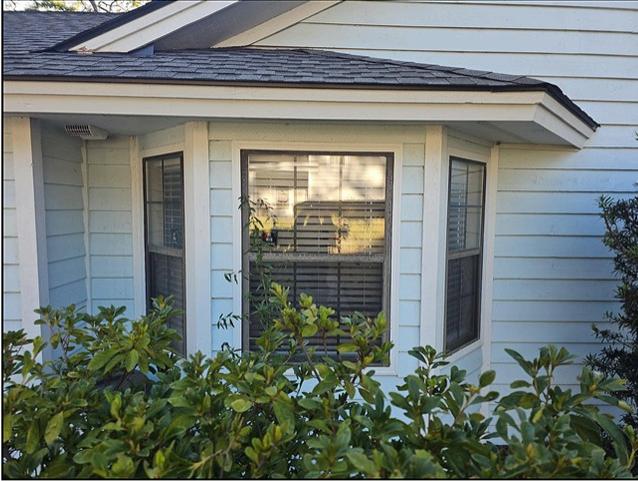
**6.8 (1) Observation:** Dry-rotted window trim at exterior windows (bay windows and one sliding window on right side).

bay windows on right side: dry-rot present at some locations on window trim

**Recommendation:** A carpenter repair and re-seal the trim around the affected windows.

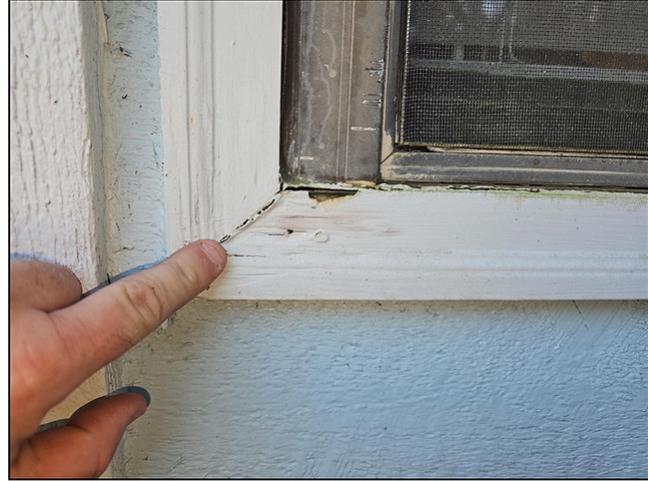
dry-rot on wood trim at beveled corners

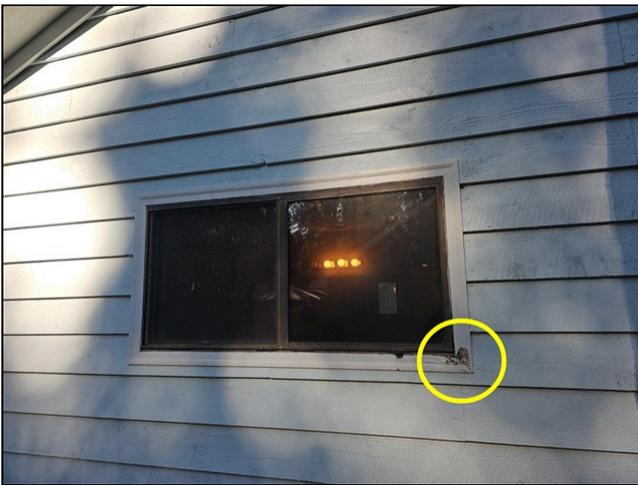
right side: dry-rot on wood trim at beveled corner

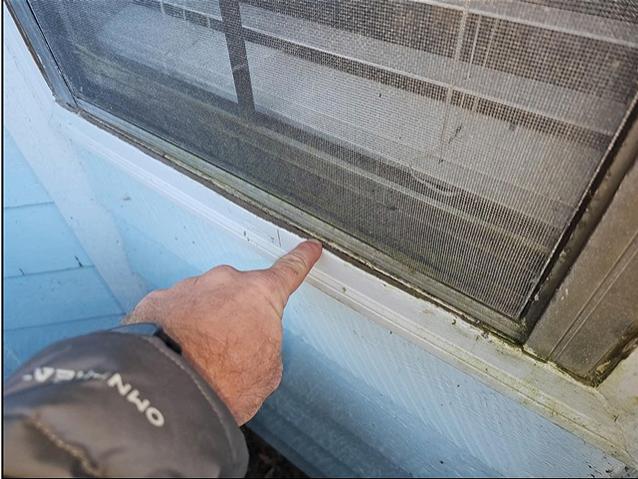
**6.8 (2) Observation:** Deficient caulking around exterior windows.

degraded sealant around exterior perimeter of most windows

**Recommendation:** Reapply sealant around all exterior window frames.

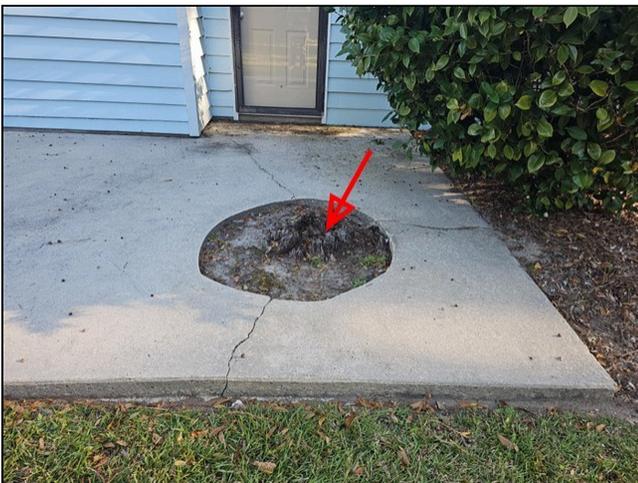
**6.9 (1) Observation:** A decaying tree stump growing near the structure at the referenced location.

**Comment:** Decaying wood attracts termites, which can cause catastrophic damage to wood-framed structures.

decaying stump within patio slab

**Recommendation:** A tree expert grind or otherwise remove the stump to avoid attractive wood-destroying organisms (WDO).

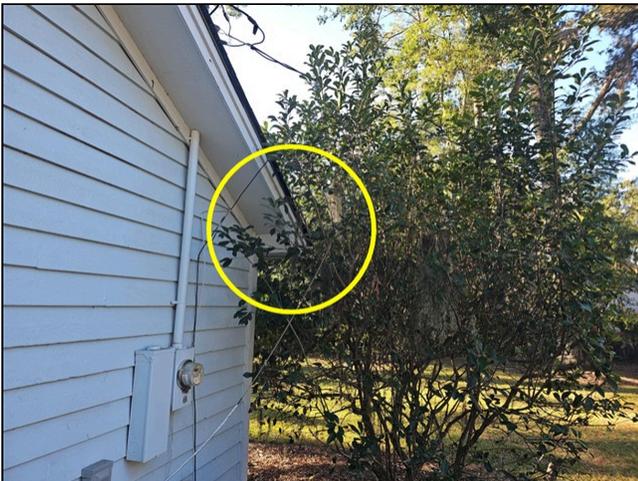
**6.9 (2) Observation:** Landscaping was overgrown and/or grew in contact with the home at the referenced locations.

rear-right corner: bush in contact with roof

Recommendation: Prune or trim landscaping such that there is a minimum of 12" open space between the exterior wall and vegetation to allow for proper ventilation.

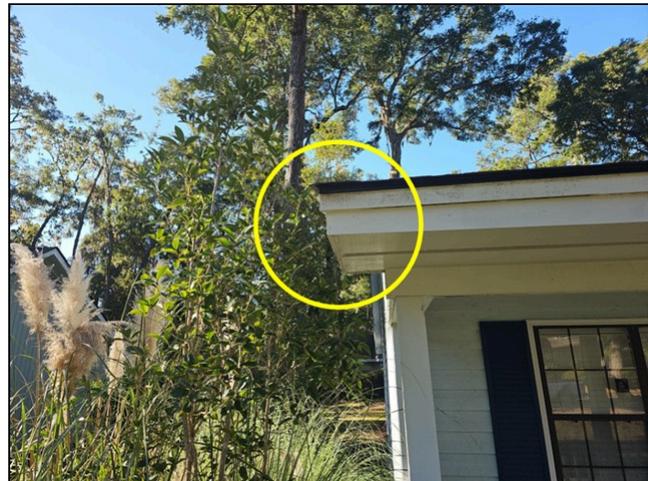
front-left corner: tree in contact with roof

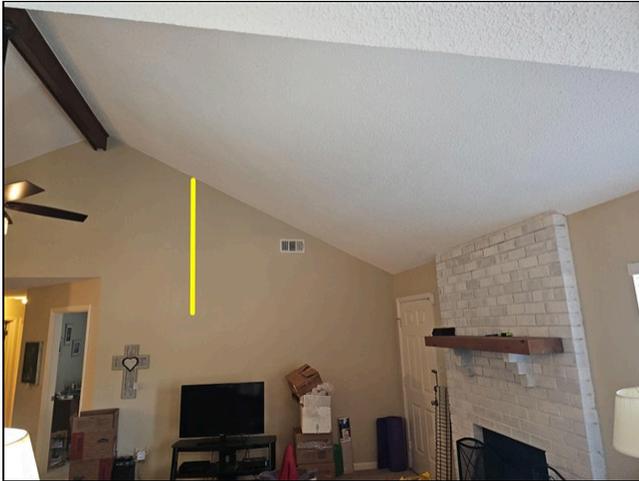
**7.1 Observation:** Two vertical hairline cracks in the living room drywall.

general location of crack #1 in living room wall

Recommendation: A professional painter patch and paint the cracks and then monitor the areas over time.

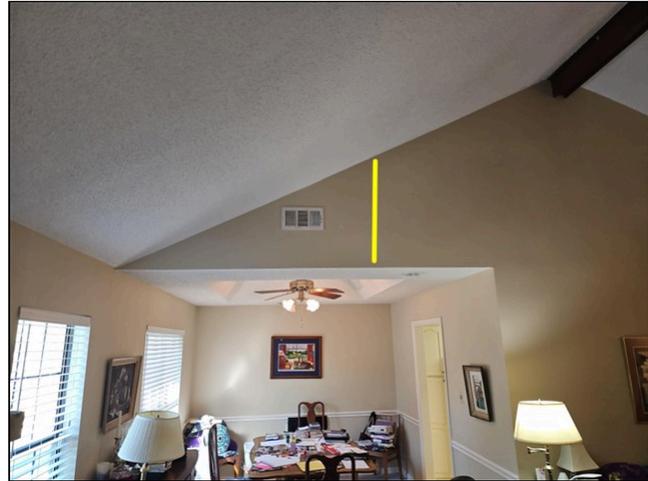
general location of crack #2 in living room wall

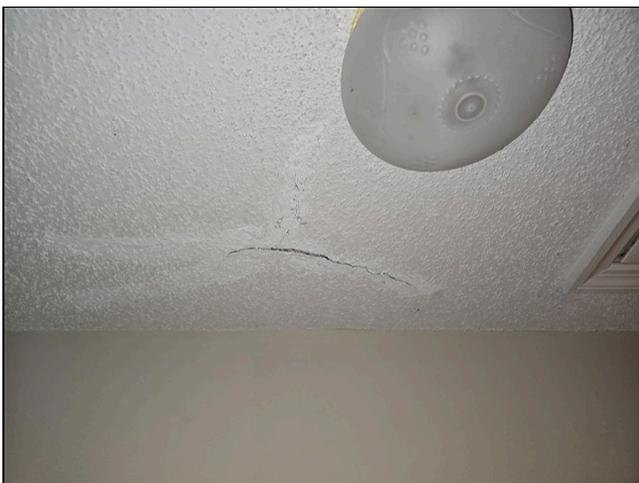
**7.2 (1) Observation:** Cracking on the ceiling near the attic access in the hallway, likely caused by someone having stepped on this area from within the attic above.

crack in hallway ceiling near attic access

Recommendation: Repair by drywall specialist.

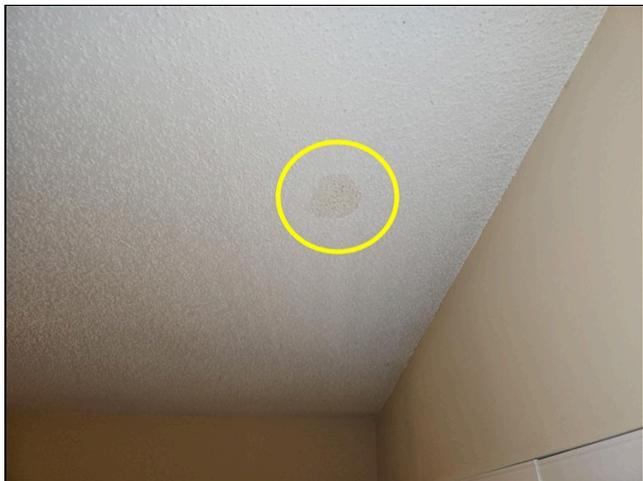
**7.2 (2) Observation:** Small moisture stains were found on the interior ceilings.

Comment: A moisture meter was used and indicated that the stains were dry. There were no indications of current leakage when inspecting the roof from within the attic, so it's possible these stains are the result of leaks that occurred prior to the current roof covering being installed.

moisture stain on ceiling in primary bedroom

Recommendation: A professional painter repaint the interior ceilings where necessary.

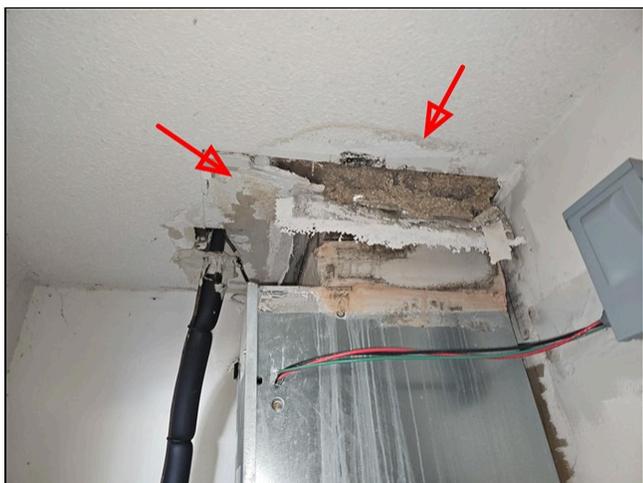
**7.2 (3) Observation:** Minor drywall damage and some moisture staining on the ceiling surrounding the area where the HVAC duct entered the attic.

ceiling damage & moisture staining where HVAC duct entered ceiling (garage closet)

Recommendation: Repair by a drywall specialist.

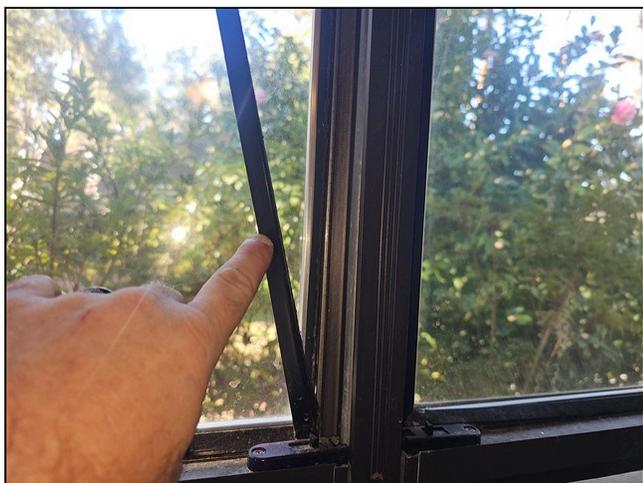
**7.4 (1) Observation:** A detached glazing bead at a primary bedroom window.

primary bedroom window: glazing bead was detached

Recommendation: Repair by a window specialist.

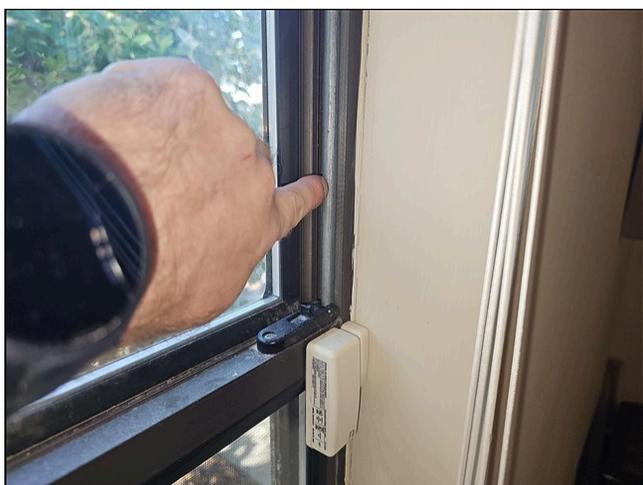
**7.4 (2) Observation**: Most windows were difficult to open and close due to worn balance mechanisms.

worn counterbalance springs at most windows

Recommendation: A window specialist replace balances on all windows that function poorly.

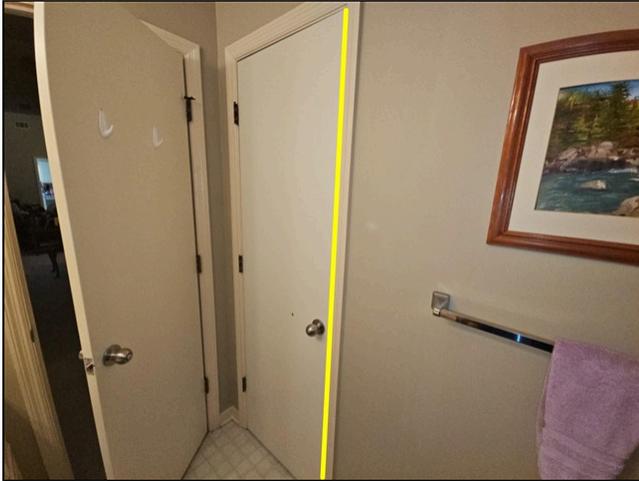
**7.7 Observation:** The edge of the closet door rubbed the jamb in the hall bathroom.

hall bathroom closet door rubbed frame

**Recommendation:** Repair by a carpenter.

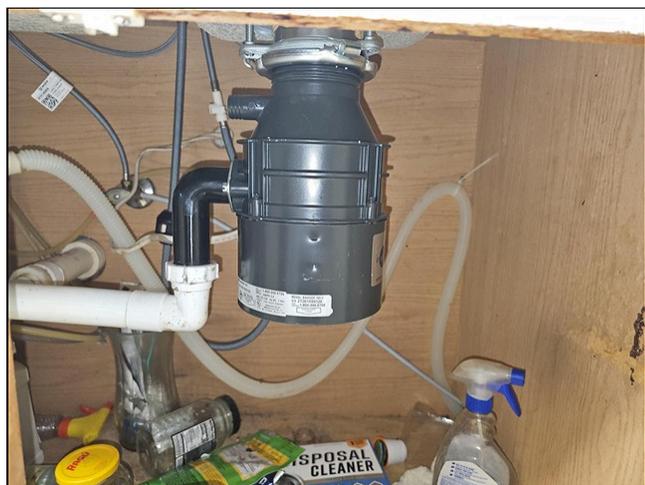
garbage disposal installed on septic system

1. Use septic-assist models - Consider investing in a garbage disposal designed for septic systems. These units often use enzymes or microorganisms to help break down food waste more effectively.
2. Pump your tank regularly - You should have your septic tank pumped every one to two years to prevent buildup.
3. Grind only small food scraps - Only put soft, non-fibrous, and easily biodegradable scraps into the disposal.
4. Avoid certain items - Do not put oil, grease, fats, coffee grounds, pasta, rice, eggshells, or other expandable or non-food items into the disposal. These items can cause clogs or damage the system.
5. Run with water - Always run plenty of cold water while using the disposal and for a few seconds afterward to help flush food particles through the system.

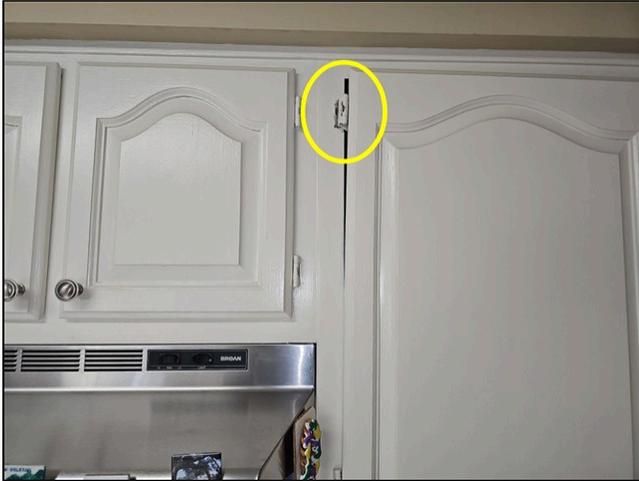
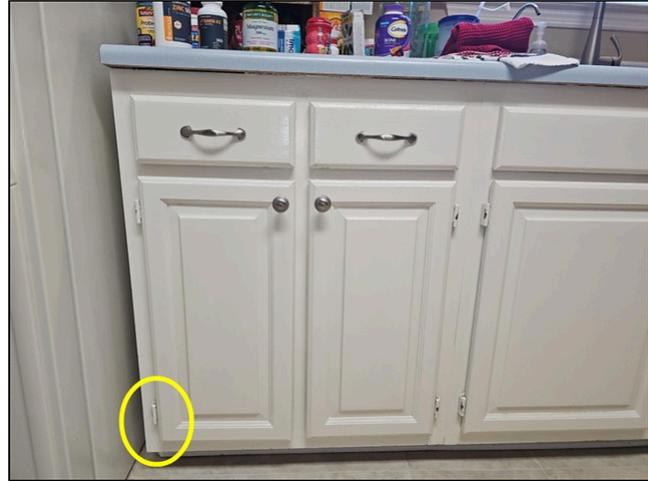
**8.6 (1) Observation:** Cabinet hinges were loose at the referenced locations.

loose cabinet hinge

**Recommendation:** A carpenter or other qualified professional repair the loose hinges.

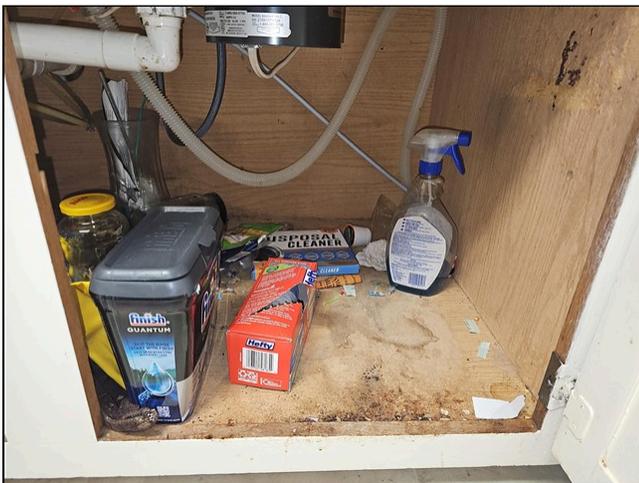
**8.6 (2) Observation:** There was minor damage to the kitchen sink cabinet base, apparently due to past leakage. The interior surfaces of the cabinet were stained and there was minor water damage.

minor damage and staining within kitchen sink cabinet base

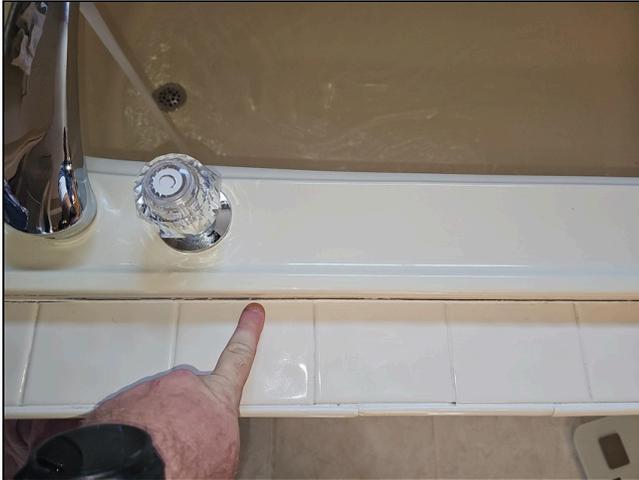
unsealed edges around tub

**Recommendation:** A tile specialist re-grout and/or re-seal where necessary to prevent leakage and moisture damage.

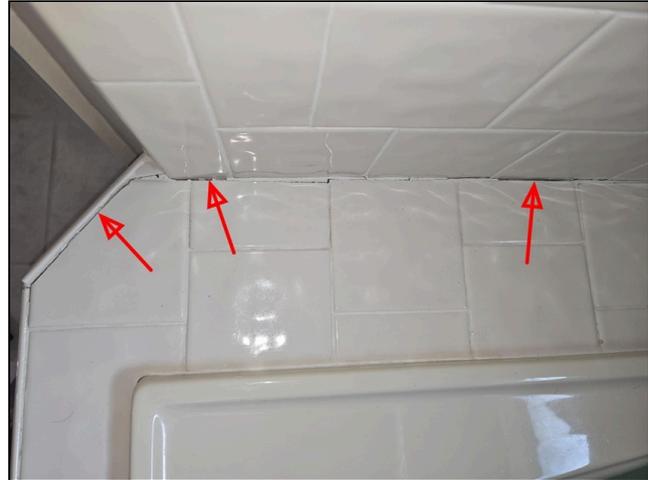
gaps in sealant/grout on tiled tub perimeter

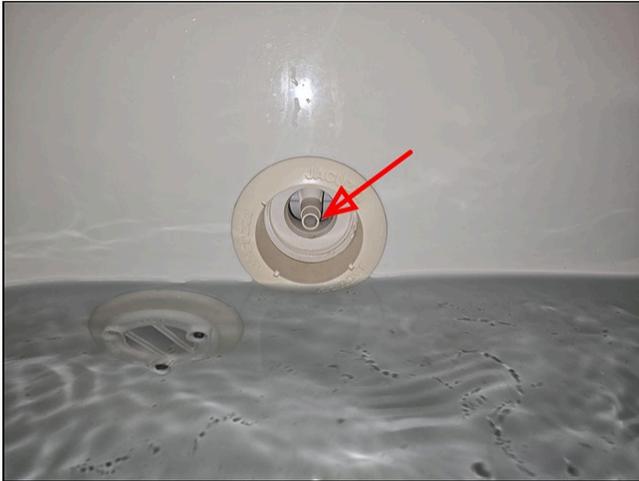
**9.0 (2) Observation:** The adjustable knob was missing at one jet at the jacuzzi tub in the primary bathroom.

primary bathroom: 1 x jet nozzle head was missing

**Recommendation:** A licensed plumber replace the adjustable knob.

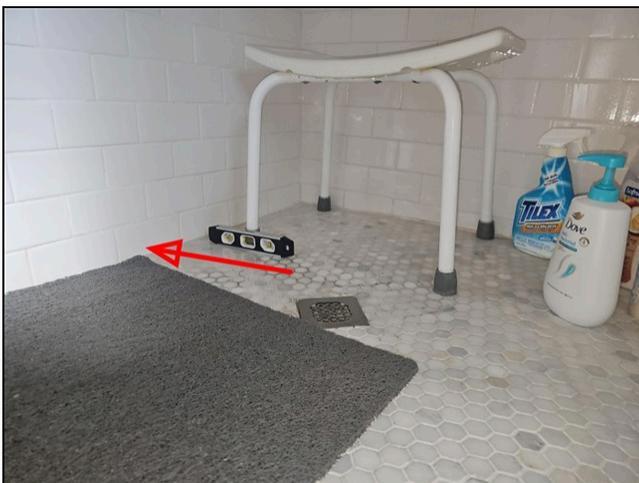
**9.1 Observation:** The tiled showerpan in the primary bathroom sloped away from the drain.

**Comment:** Water may sit against the sidewall of the shower here, which increases the risk of through-wall leakage and moisture damage. There were no indications of moisture damage as a result of this condition at the time of inspection.

primary bathroom: shower pan sloped away from drain

**Recommendation:** Further evaluation by a plumber or tile specialist and repair as needed.

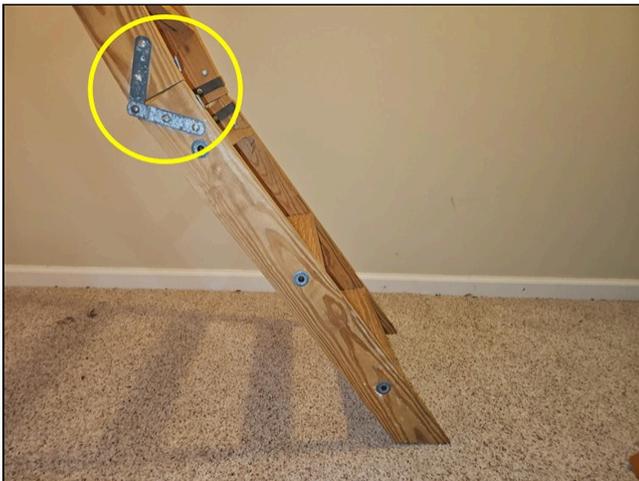
attic pull-down ladder: hyperextended hinges

**Recommendation:** A qualified professional replace the pull-down attic ladder.

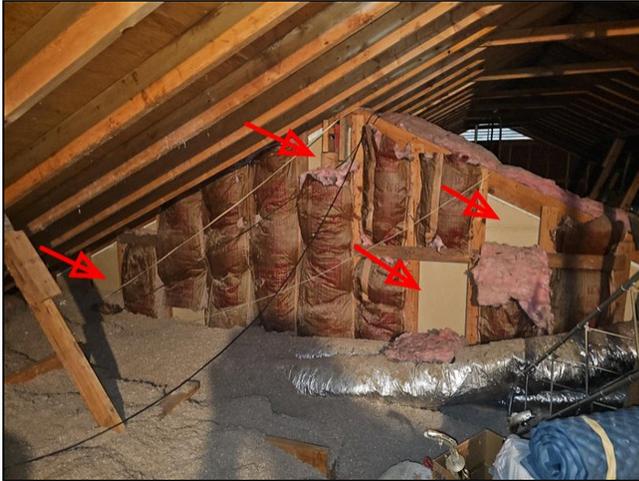
insulation missing at multiple stud bays at both sides of vaulted living room ceiling

Recommendation: A qualified contractor install insulation where missing.
