INSPECTION REPORT  
1 Main Lane  
Savannah GA 31419

INSPECTED BY  
Keith Ware  
Pride Home  
Inspections, LLC

INSPECTION DATE  
📅 11/11/2025  
🕒 09:40 AM

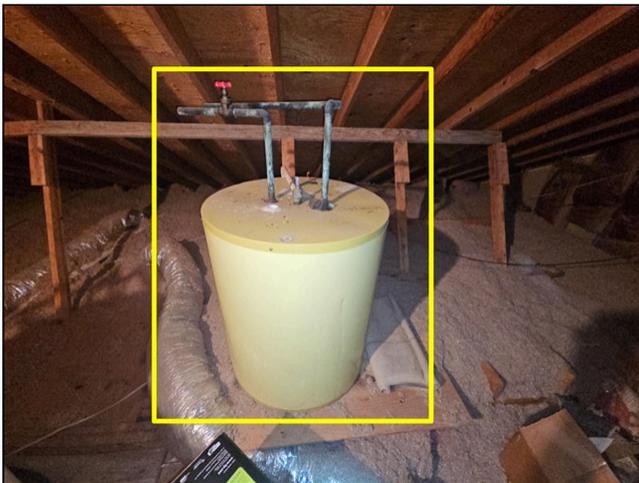
old, disconnected water heater left in attic

Recommendation: Have the equipment removed prior to purchase to avoid a future expense.

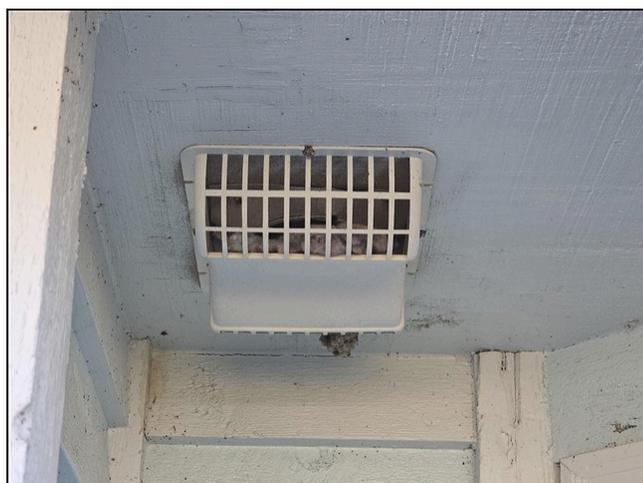
lint buildup within exterior dryer vent housing

**Recommendation:** Remove the plastic screen and lint.

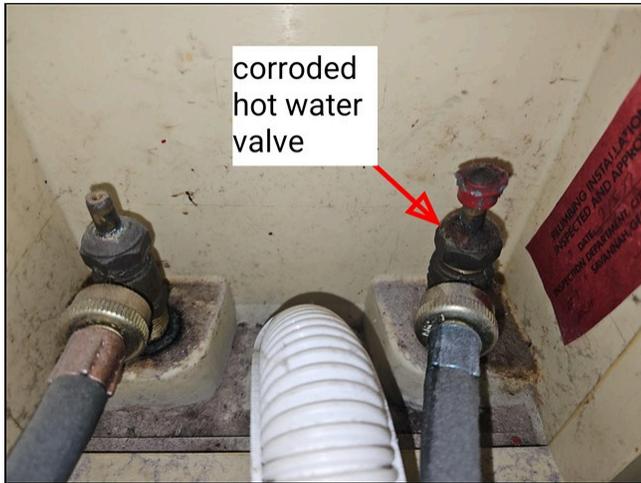
corroded valve and missing handles

**Recommendation:** A licensed plumber install handles and replace the corroded valve.

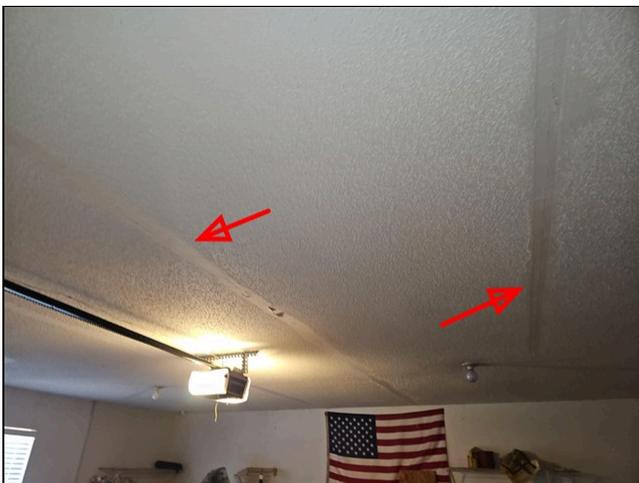
garage ceiling: drywall joint tape separation

Recommendation: Repair by a drywall specialist.
