INSPECTION REPORT  
207 Juniper Court  
Savannah GA 31405

INSPECTED BY  
Keith Ware  
Pride Home  
Inspections, LLC

INSPECTION DATE  
📅 11/10/2025  
🕒 10:00 AM

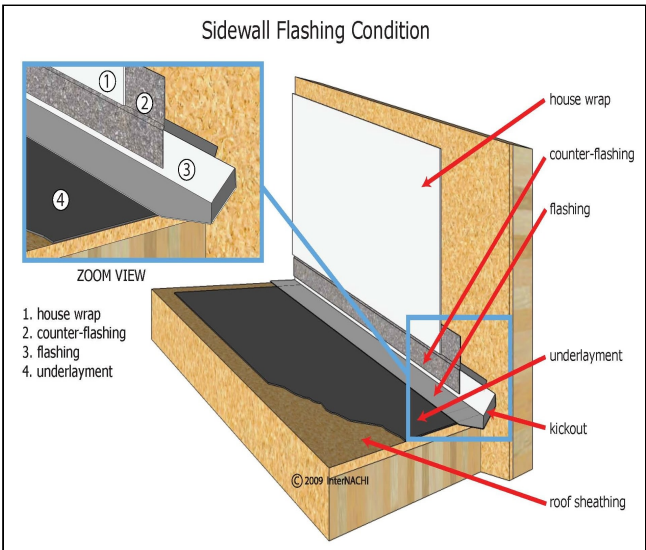
2.1 (1) Observation: A kickout flashing was missing at the referenced location.

kickout flashing diagram

**Recommendation:** Repair by a licensed roofer.
