INSPECTION REPORT  
1 Main Lane  
Savannah GA 31419

INSPECTED BY  
Keith Ware  
Pride Home  
Inspections, LLC

INSPECTION DATE  
📅 11/11/2025  
🕒 09:40 AM

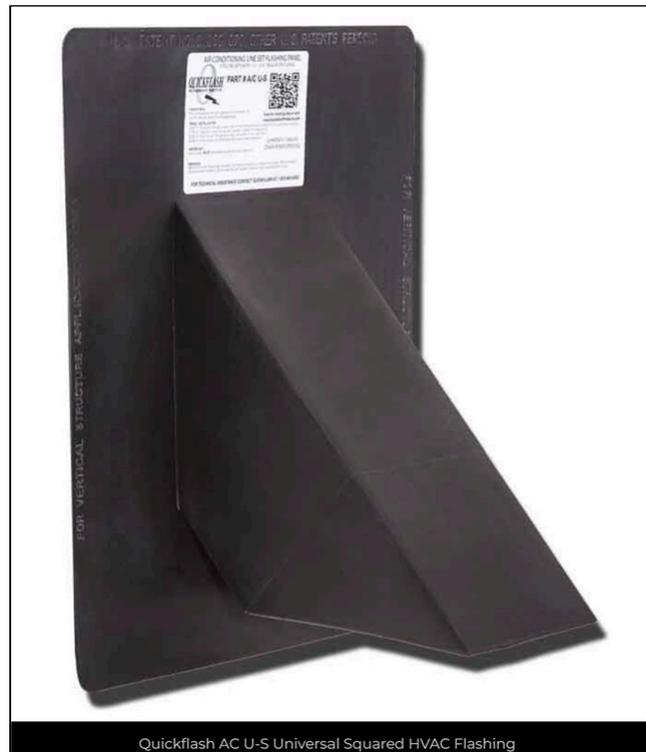
wall flashing example

no insulation on refrigerant line where it entered the wall & unflashed exterior wall penetration

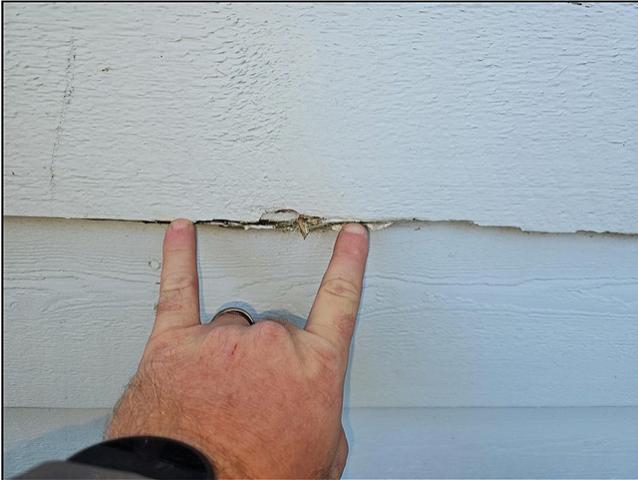
rear exterior wall: dry-rotted siding

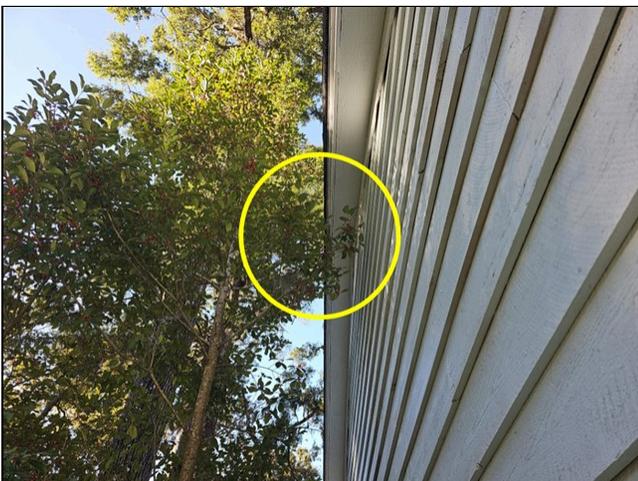
left side: tree in contact with exterior wall
